Another 70K-2 PTO Repair Story

By Ernst F. Schroeder DJ7HS

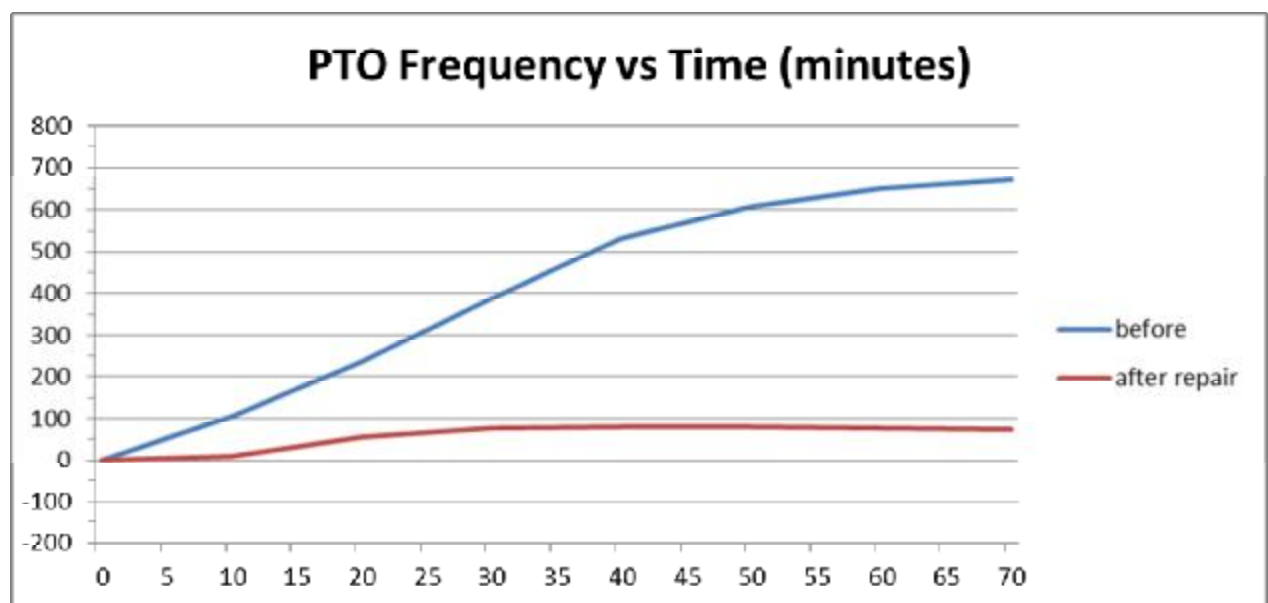
In the fall of 2017 I had come into contact with Peter, OZ8CTH. He complained that the PTO inside his KWM-2 had become quite unstable, showing a large drift at warm-up and occasionally some jumps in frequency.

Peter had measured the frequency drift at start-up inside his KWM-2. This is one of the curves in **Fig. 1**.

When the PTO had returned to Denmark and was put into the KWM-2, Peter took another set of values for frequency drift. This is the second curve in Fig. 1, and indeed frequency drift has improved very much.

Fig. 1 PTO drift from cold start

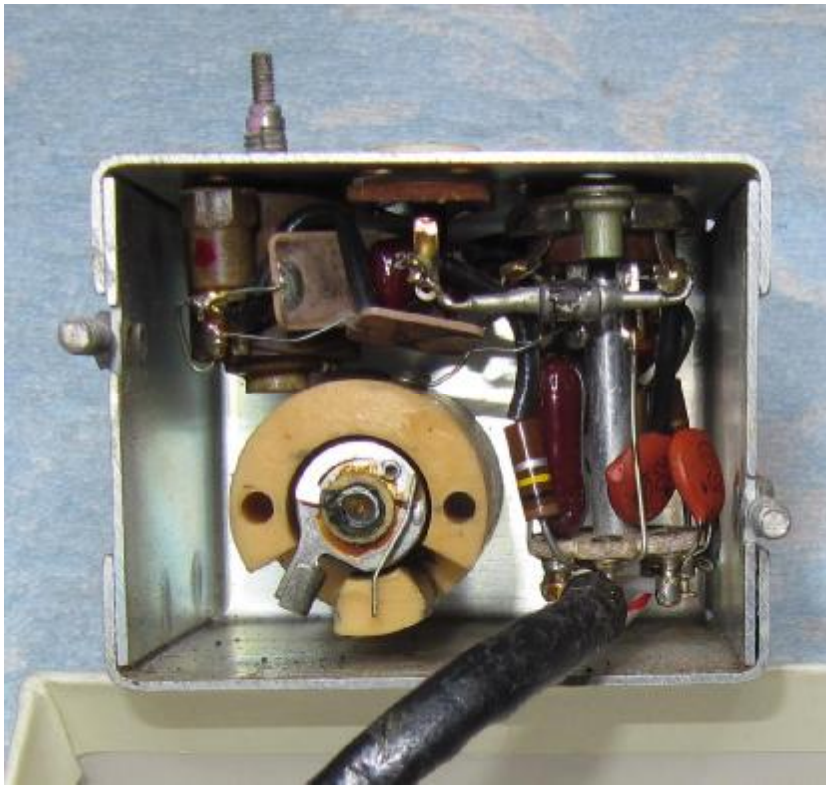
But at this very moment it became clear that trimmer C308, which had not been touched before, was indeed faulty. It was not possible to set the USB/LSB frequency shift. Upon closer inspection some traces of lacquer were visible. Someone had probably tried to "lock" the trimmer.

Fig. 2 Look into the PTO before servicing

- The idle frequency of the PTO outside the box and without spindle was 2.754 MHz.
- First capacitors C306, C307, C309 and C310 (all .02 uF) were replaced with new ceramic 22 nF 500 V types. There was no noticeable change in stability.

- Next capacitor C304 (was 207 pF) was to be replaced. As no 200 pF dipped mica capacitor had been available, it was changed to 50 pF mica (actually 55 pF). This is according to change 20B in the 9th ed. KWM-2 instruction book, Collins 1978. C304 couples the grid-to-ground capacitance of V301 into the circuit, so the total is now smaller. This reduction of capacitance led to an expectable rise in frequency of about 900 Hz.

- Next the switching diode CR 301 (1N34A) was replaced with a type 1N4148 silicon diode. After that there was the impression that the irregular frequency jumps were less frequent. The smaller capacitance of this diode let the idle frequency rise by another 300 Hz.

- Next capacitor C303 (was 3051 pF) was replaced with a new mica type with actually 3035 pF. This let the frequency further rise to a total of +3500 Hz.

- Then C302 (was 999 pF) was replaced with a new mica type with actually 1008 pF. This increase in capacitance let the idle frequency drop to -1200 Hz. And more importantly, the irregular frequency jumps seemed to have disappeared.

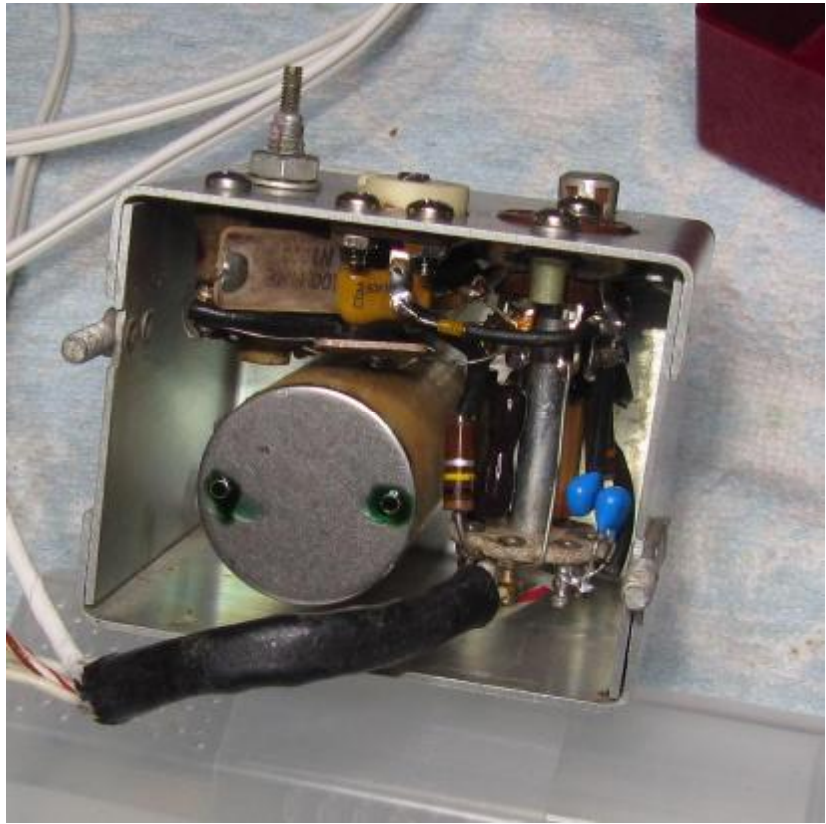
Fig. 3 Look into the PTO after servicing

After all this the PTO was reassembled inside the box, the spindle was thoroughly cleaned and fresh lithium grease was applied. Then the PTO was pre-aligned to ease alignment after inclusion into the KWM-2.

So the PTO had to come out of the box again and trimmer C308 was disassembled and cleaned, following the instructions given by Glen Zook, K9STH (*2). After that it was again possible to adjust the USB/LSB frequency shift to about 2.7 kHz.

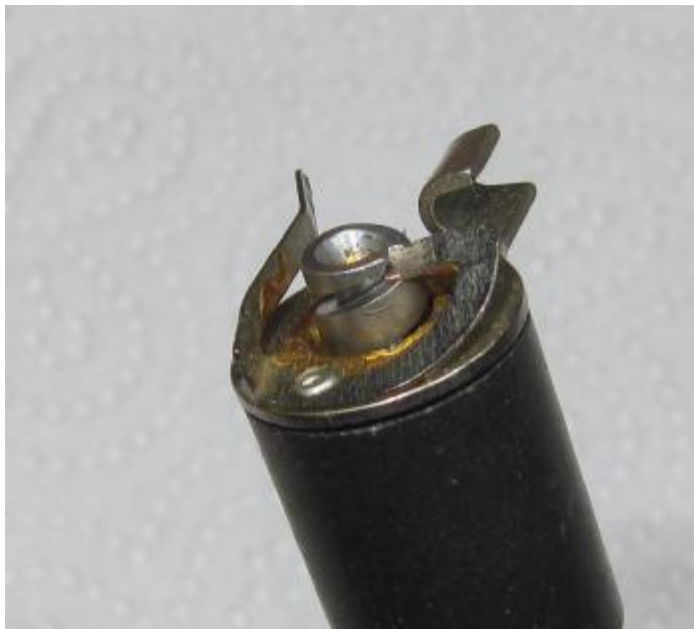
Upon reassembly it can happen that the little nose is not engaged in the correct groove and consequently there is not enough spring action in axial direction. Fig. 4 shows the correct position when the spindle is just being inserted.

Fig. 4 Metal and spring assembly at the PTO core
