TECHNICAL INFORMATION #920

Re: IC- 7400/IC-746PRO Modification No.124

The following modification is regarding the improvement of IC-7400 and IC-746PRO.

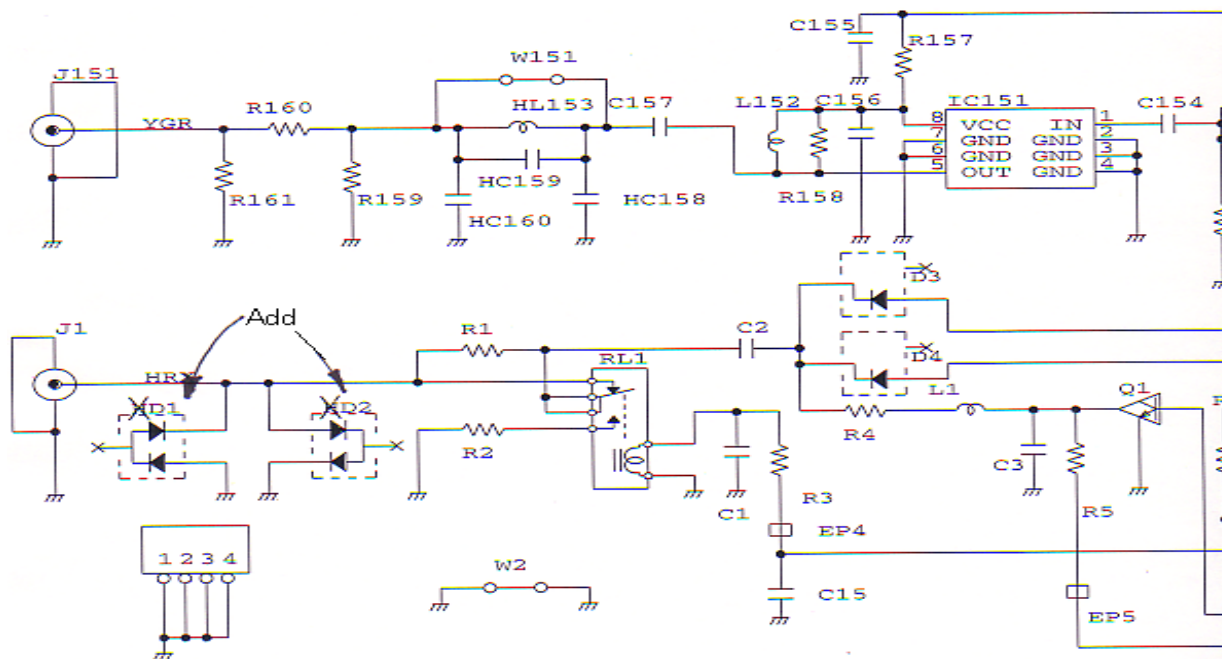
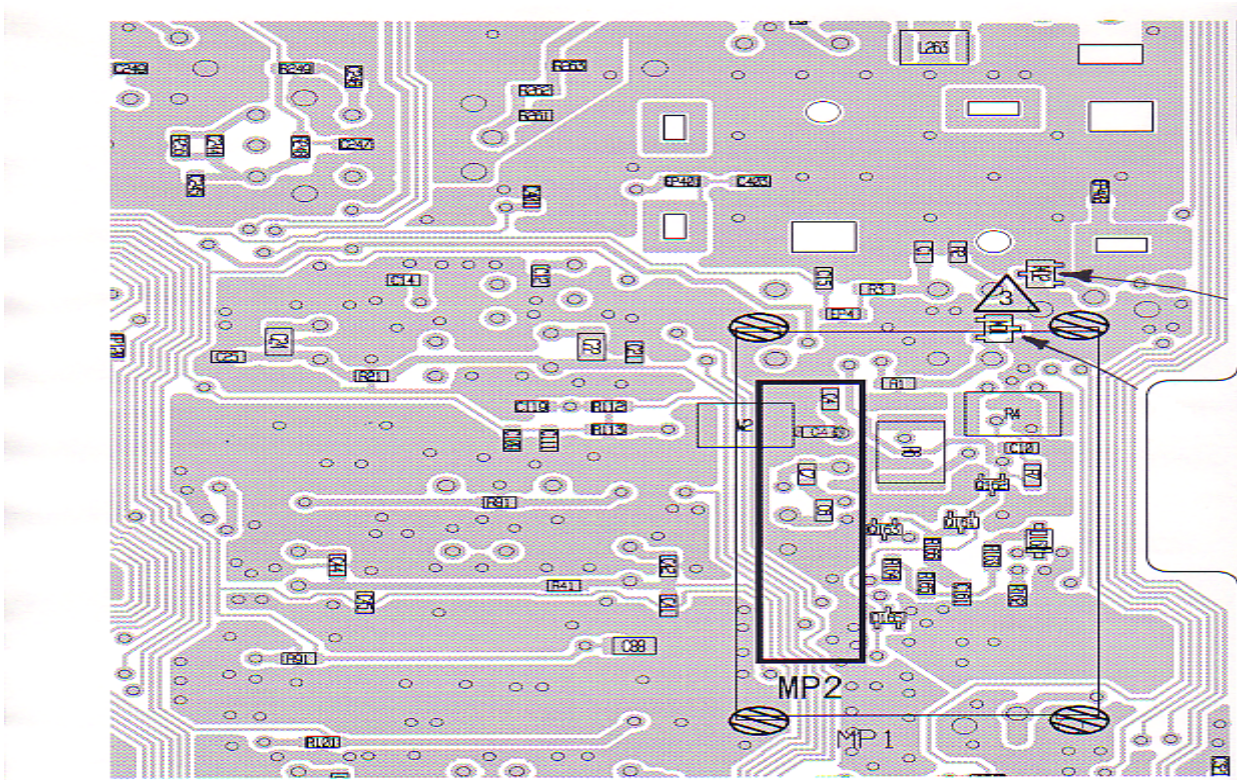
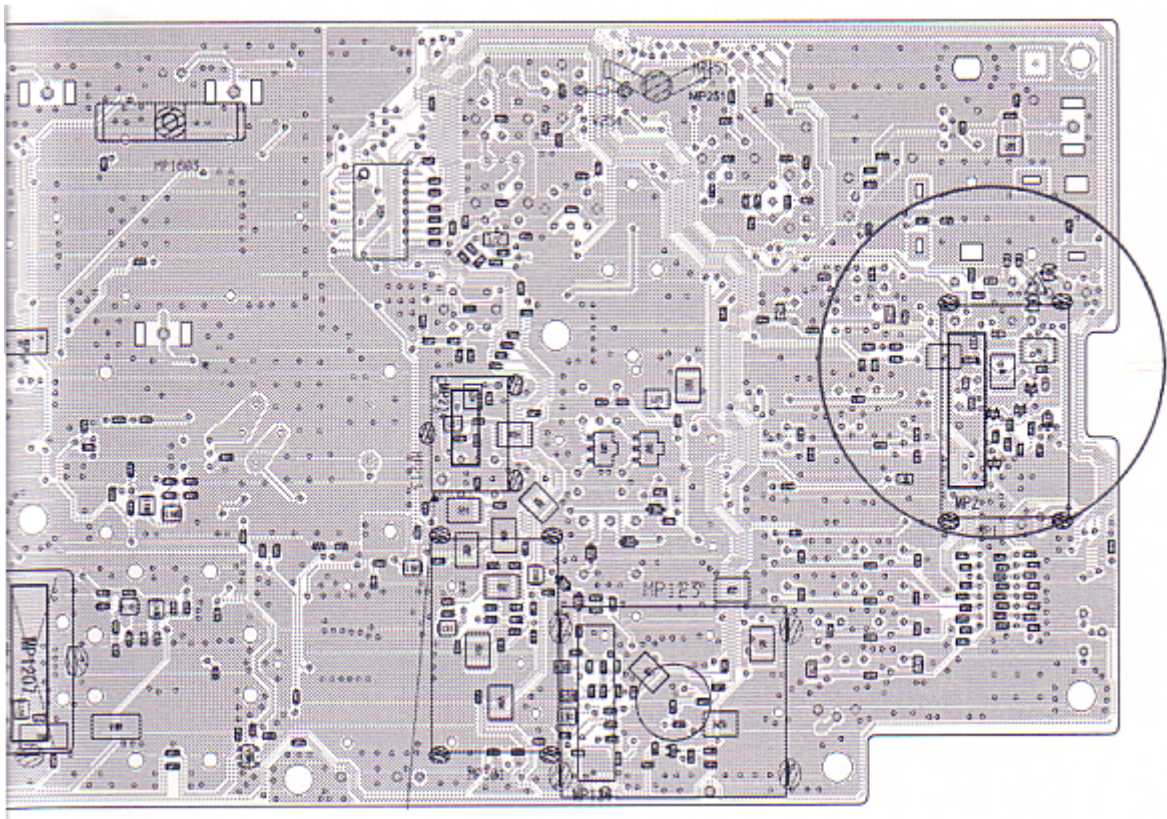
Symptom: No output power on the TX mode.

Cause: The IC151 is damaged because of static electricity.

Solution: Add two PIN diodes on receiving line as follows,

Board	Parts Number	Parts Number (Old)	Parts Number (New)	Action Taken
RF 130	D.1	NA	1750000350 S.DIODE TOSHIBA 1SV252	Add
RF 130	D.2	NA	1750000350 S.DIODE TOSHIBA 1SV252	Add
