Tempo 2020 Preselector Sprocket and Chain Replacement

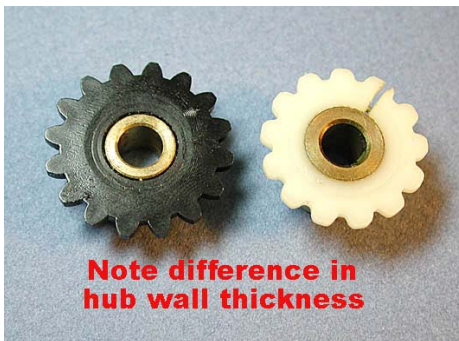
The SDP/SI part numbers are ~~AGY8M211606~~ for the sprocket and ~~AGY8M21~~ for the chain. The sprockets are priced individually, and the chain is priced by the meter. The sprockets not exact replacements for the 2020’s sprockets, as the 2020 has 13-tooth sprockets, and the replacements are 16-tooth. Also, the replacement sprocket hubs are smaller in diameter and length, and the brass insert is not as thick. Replacement chain and sprocket must be matched; i.e., have the same pitch. The thickness of the teeth is fairly close, but thinner than the 2020 teeth. These factors are important; acetal is not as tough as nylon in the service they are employed.

See Photos 02 through 07b for close-ups of the replacement sprockets and their differences from the originals. The difference in manufacturing is evident. The original sprockets were molded onto machine-crosshatched brass hubs. The replacements appear

to have been glued onto considerably thinner brass hubs. The setscrews in the replacements are not as substantial, also they use Allen drive as opposed to Torx drive. Combined with the thinner brass walls of the hubs, this implies that the setscrews can’t take as much tightening torque.
