## Butternut HF6V vertical antenna repair

Klaus illhardt  
VK3IU

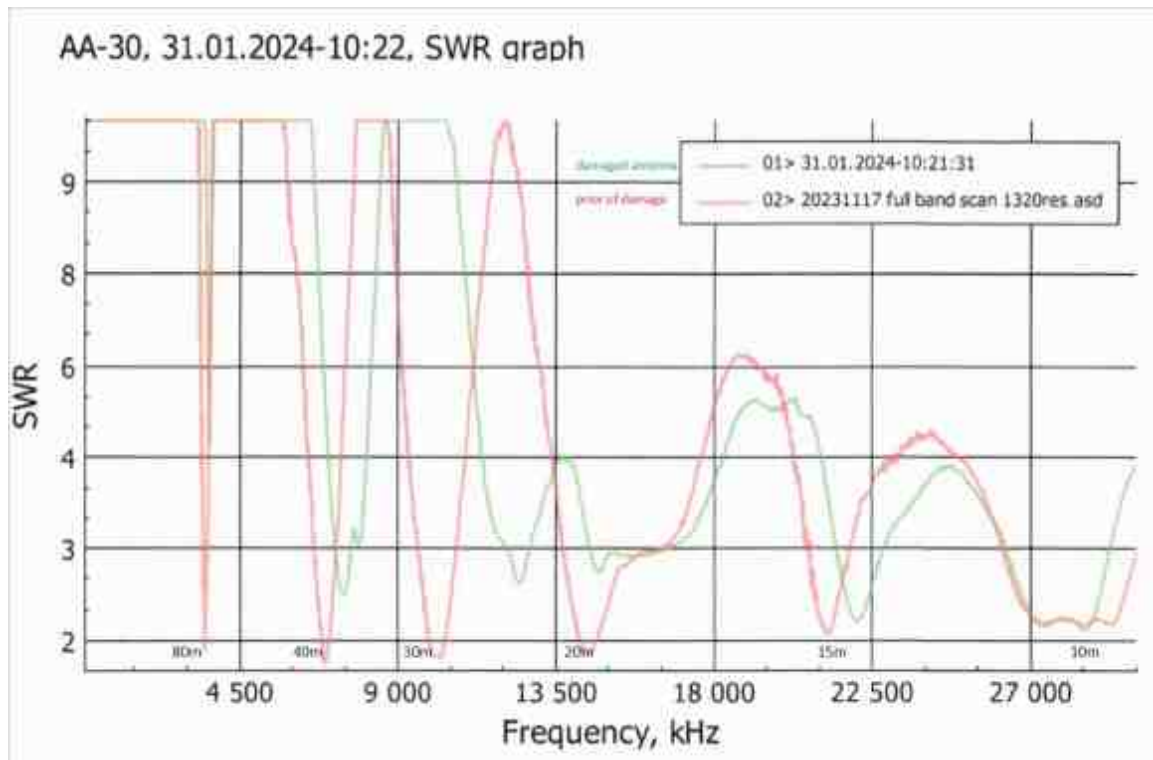
The measurements of the antenna with an antenna analyser confirmed the observation of a major change in the SWR curve..

GREEN shows the damaged antenna, compared to RED which shows the antennas SWR before.

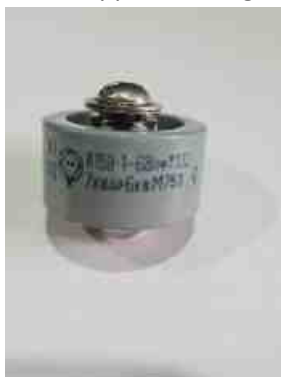
New capacitor

Unfortunately the cost of the original replacement 67pF doorknob capacitor imported from the US would almost have been 150\$ AUD for one. Luckily I found a supplier in the Ukraine specializing on such items and I purchased two 68pF doorknob capacitors for 50\$ AUD shipped withing 2 weeks.

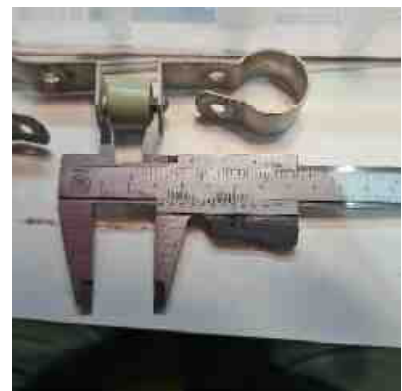
Based on the build of the Butternut HF6V my suspicion fell immediately on the 30m assembly of the antenna which influenced the 20m and 30m band. I posted a description of my problem in the forum of eHAM.COM and got a lot of good replies which lead me to believe that the culprit is very likely the 68pf doorknob capacitor of the 30m assembly.

Above damaged capacitor

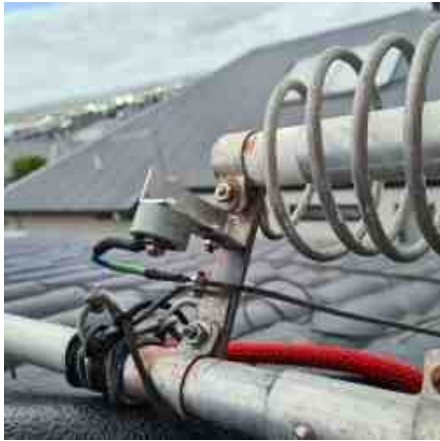
I also found through the replies in *eHam.com* a modification and detailed description provided by Phil AD5X with whom I exchanged several emails about this issue. The experience seems that the 30m doorknob capacitor is exposed to mechanical stresses due to its assembly. The modification was simply to build a small aluminium bracket and connect one side of the capacitor with a flexible wire to the antenna. See picture below.

Replacement of the 30m, 67pF doorknob capacitor with a 68pF and the modified mounting.

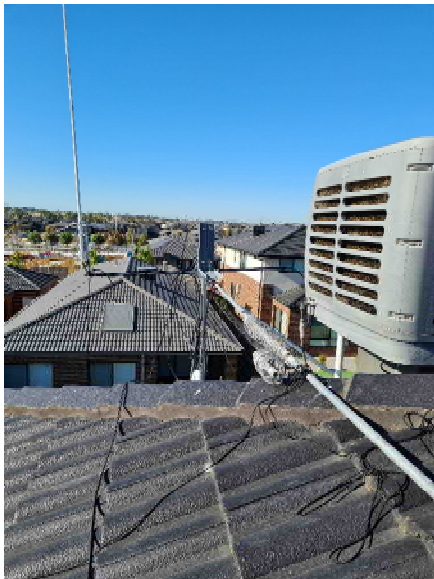
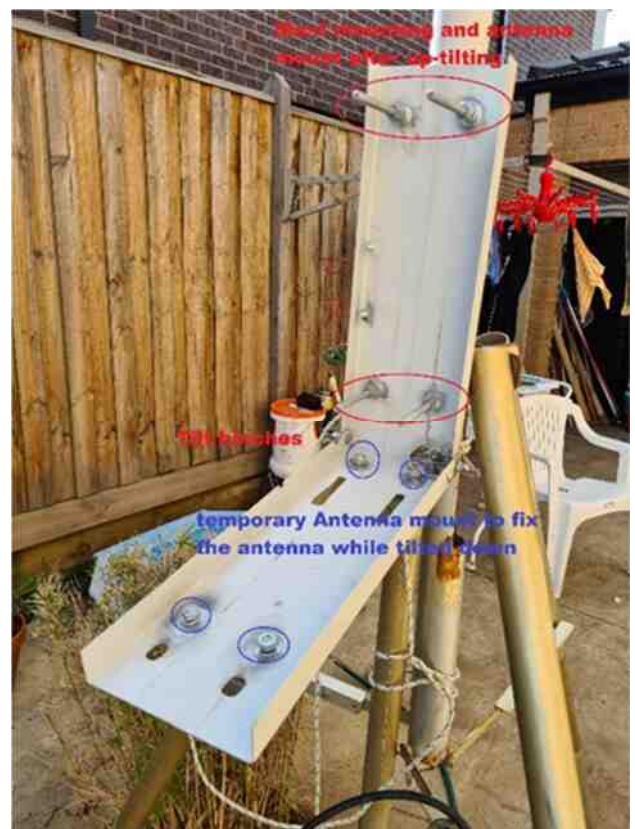
In my case the antenna is mounted on top of a two-story home. I build a tilt mechanism which allows me an easier access to the antenna, which when tilted down allows the antenna to lay flat on the roof for easy access and maintenance.

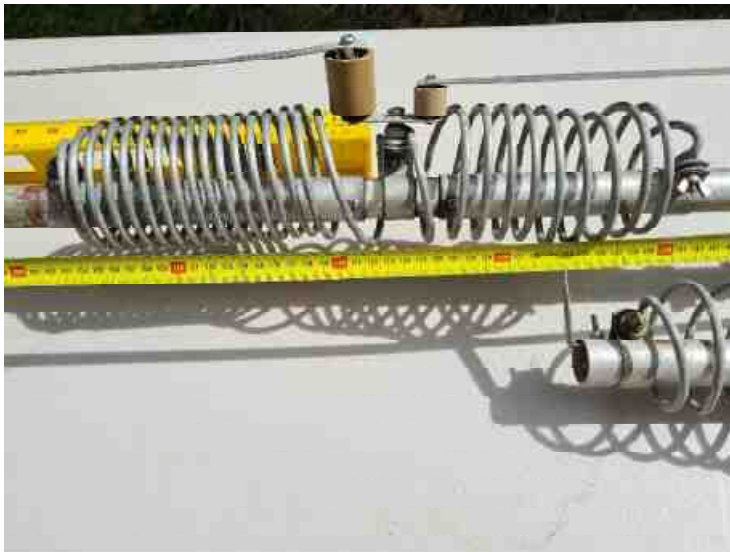
Initially I suspected the 200pf 80m doorknob capacitor, but it measured fine, so did the 67pf 40 doorknob capacitor, which kept me at a loss.

80/40m assembly, Doorknob Capacitors (left 200pF/80, right 67pF/40m)

I also decided to disassemble the shown above 80/40m assembly to clean the contact, during this activity I noticed that the 67pF doorknob capacitor for 40m had a loose assembly socket, which could be moved left right. This is the same doorknob capacitor as for 30m. It seemed that they are easy to get damaged due to external mechanical forces. In line with the previous repair I decided to install a stress relieve point to remove the direct mechanical force on the doorknob capacitor, I was also lucky that I purchased 6 month ago two of this kind.

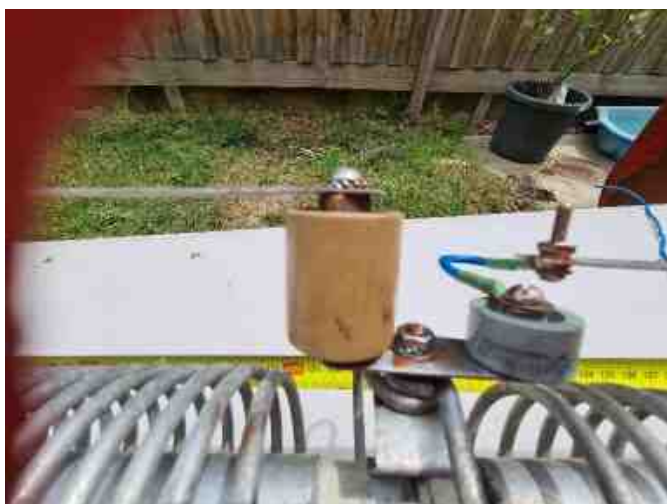
Replacement capacitor with stress relieve (right)

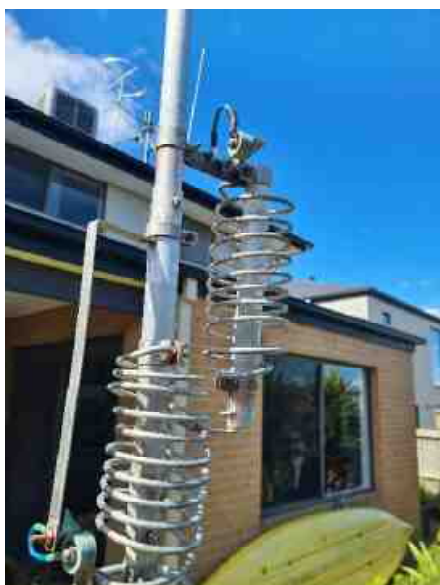
Picture above the 40m and 30m assembly with stress relieve for the two identical doorknob capacitors.

Prior to disassembling the coil section of the antenna I took detailed measurements of the location of all assembly points. I also modified the guy point from above the recommended 30m coil and moved it up to 1.5m, where I hoped that this would limit the stress on the resonant parts of the antenna.
