DCS Radio Service Call Marina Del Rey Sheriff Station 17 Nov 2017

By Jerry Kendrick, NG6R, T-03, DCS Technical Team member

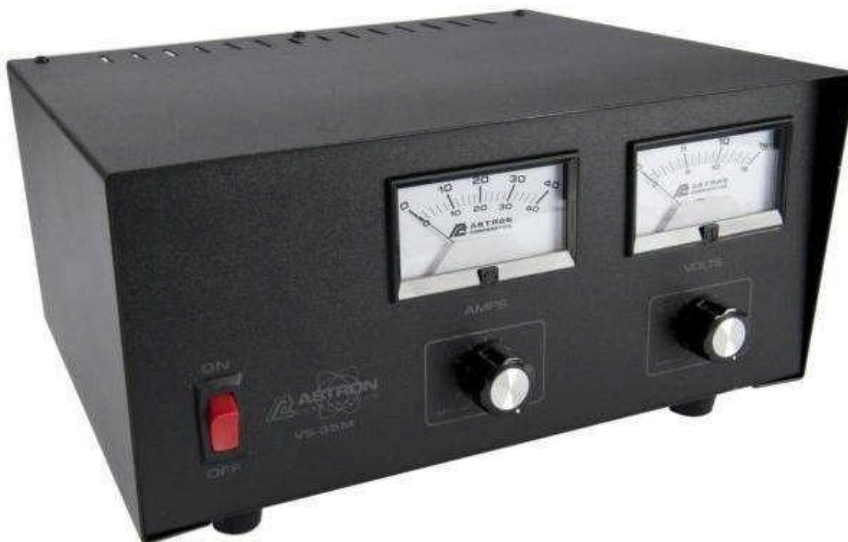
This team experienced the same symptom as had been described by the operator when the PTT switch was activated. The tell-tale squeal from the radio speaker was immediately recognized as indicative of low DC power applied to the radio. The power supply is an Astron VS-35M, as shown in the stock photo of Figure 1.

Figure 1. Stock photo of Astron VS-35M, a dual-metered 35-ampere DC power supply with both variable output voltage and variable current limit set-point front-panel adjustments

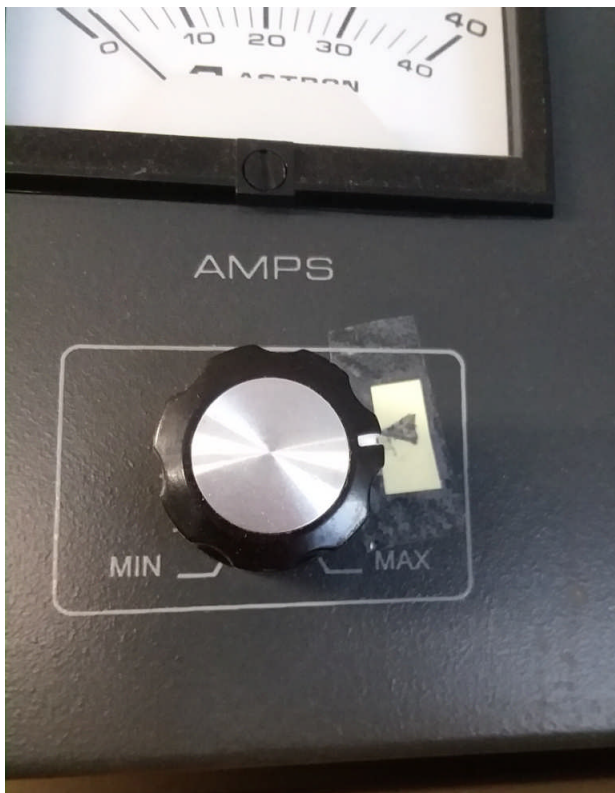
To begin the testing, we confirmed that the output voltage was set, as precisely as is possible with the supplied meter, to approximately 13.8V (just shy of the 14 volt mark on the meter dial). When this radio was in receive mode, it drew only about 2 amps. Now, when the radio PTT was keyed (with the radio set in the high-power mode), the current meter jumped to 10 amps, but the voltage meter dropped from ~13.8V to about 10V. In other words, the power supply was limiting current to 10A by reducing the output voltage—an undesirable outcome.

Figure 2. After locating the rotational position at which the “current limiting” AMPS control would enable full/desired output voltage of 13.8V without voltage scale-back, the control position was advanced a few more degrees clockwise and marked with a pointer to assure proper positioning in the future. This procedure was performed while drawing current with the radio in the high-power transmit mode.

While activating the PTT in the high-power mode (and drawing ~10 amps), we moved the AMPS control slowly CW and saw the output voltage increase until it leveled out; we stopped rotating the control when the voltage stabilized at 13.8 volts. Then, to provide some margin (for temperature, humidity, component aging, AC line voltage fluctuations, etc.) we increased the CW rotation another few degrees and marked that point with an arrowhead taped onto the front of the panel, as shown in Figure 2.

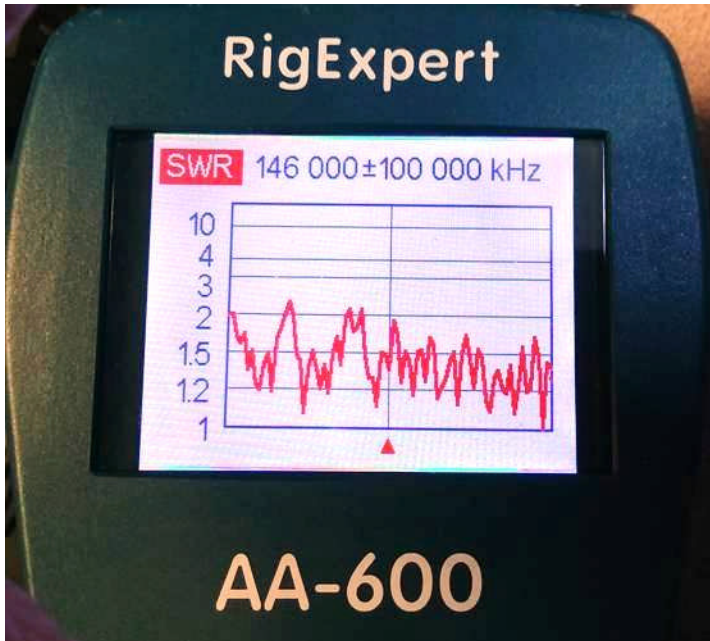
Figure 3 shows the measured antenna SWR over a very large spectrum, centered in the 2m band at 146MHz. The character of this data is unexpected. There is no clear resonant frequency and very little variation over this large spectral expanse. This raises suspicion that the antenna is defective. However, SWR being generally less than 2:1 is not causing the transceiver to fold back its output RF power. Furthermore, a simplex RF link test from MDR to Palos Verdes (approximately 16 miles) exhibited fully readable reception on both ends of the link. So, it's working even if the antenna isn't demonstrating "normal" behavior. No antenna action is deemed critical at this time, but it bears watching when an opportunity for future testing occurs at this station.

Figure 3. SWR of outside 2m antenna shows unusual behavior—generally less than 2:1 everywhere and no apparent resonance(s)

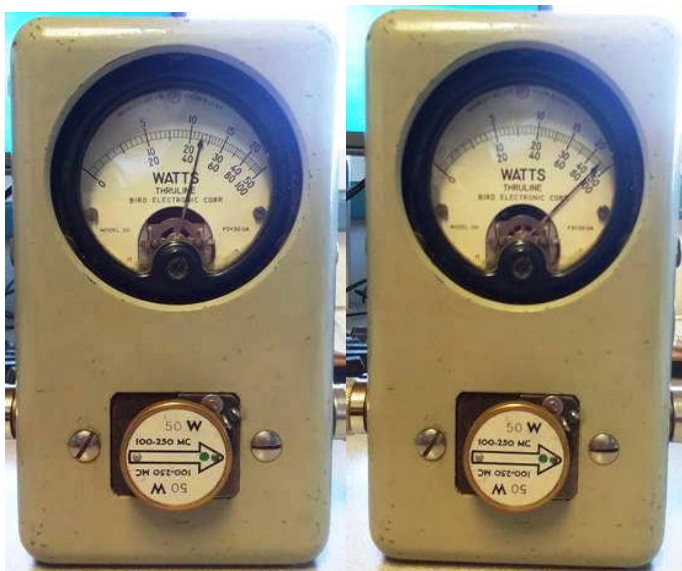
Figure 4 shows photos of the power measurement instrument in both the low-power and high-power modes. Low power output into the antenna was approximately 23 watts and in high-power mode approximately 45 watts.

Figure 4. Left and right photos indicate, respectively, output power of ~23 watts in low-power mode, ~45 watts in high-power mode

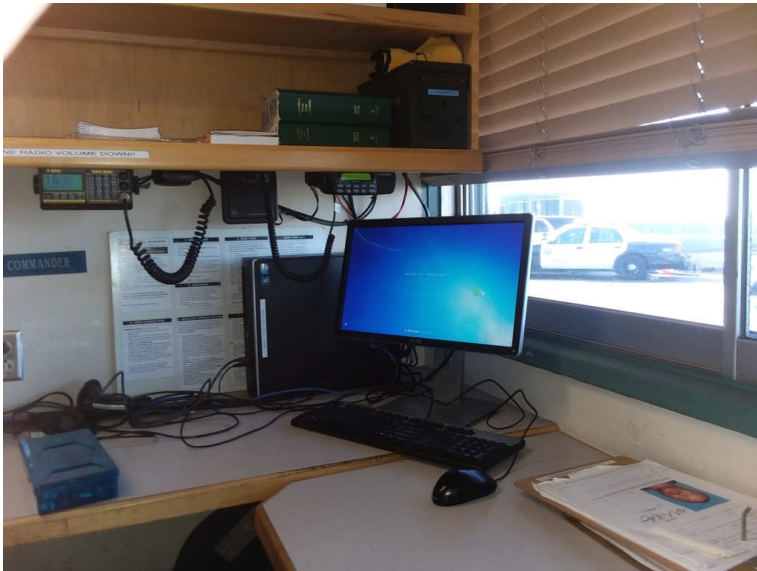
Other unrelated observations: The Tech Team members observed that the location of the transceiver coupled with the location of the computer monitor made operational access to the radio awkward. If the monitor were moved a couple of feet to the left or right, operator access to the radio would be significantly improved, as can be observed in Figure 5.

Figure 5. DCS radio and companion speaker location under shelf just behind and above computer monitor. Power supply is just off camera on the upper shelf and located roughly above the marine radio at the far left.

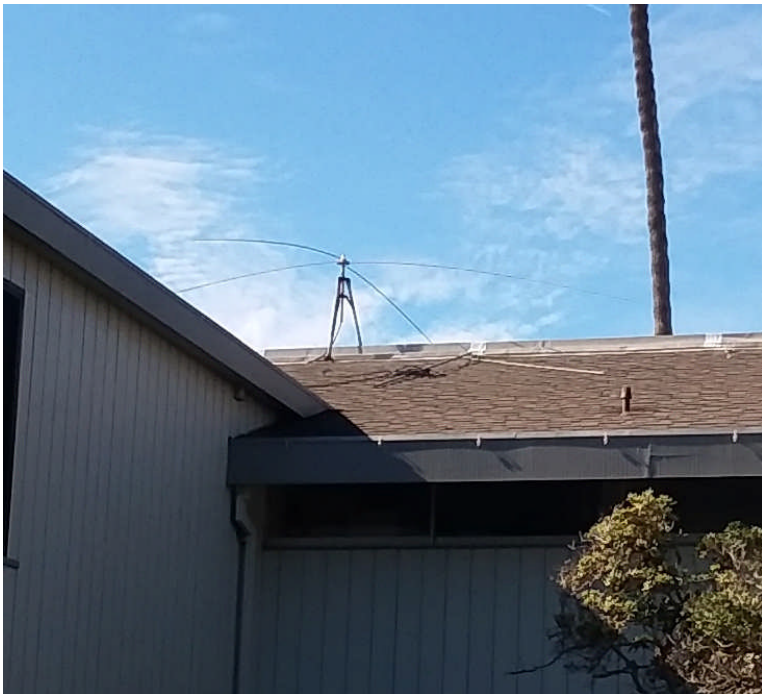
Upon approaching the MDR station, the Tech Team members observed what appears to be a damaged CB or other HF antenna, as depicted in Figure 6. The four horizontal radials appear to be intact but the vertical radiating element has been disconnected (probably broken off) and appears to be lying on the roof. This is not DCS related, but we thought it relevant to point this out for whom it might be of interest.

Figure 6. Damaged CB or other HF radio antenna atop the MDR Sheriff Station roof.
