West Hollywood Station DCS Radio Room Survey

17 July 2015

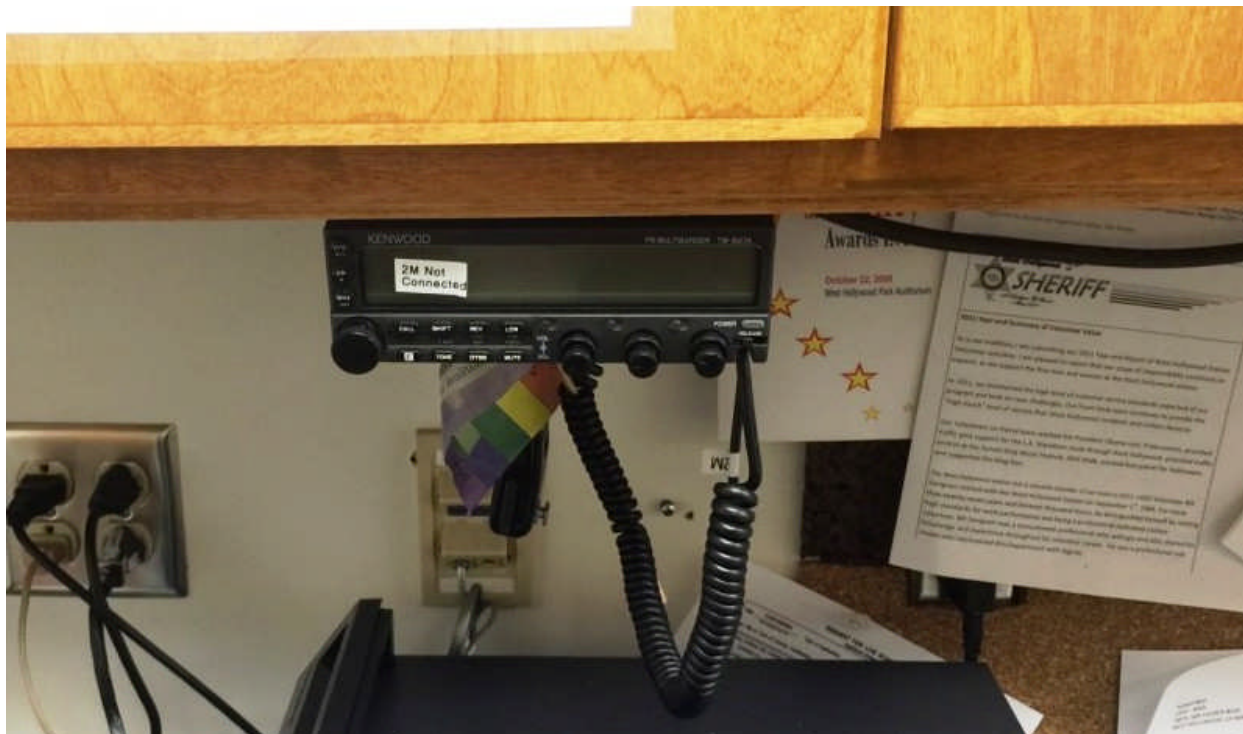
POSITION 1: Kenwood TM-641A, 2 meter (no antenna) / 220 MHz
LASD Inventory: 1317

The Kenwood TM641 has two RF slices, one for 2m and one for 220 with an option for a third band. The radio functions on both bands with rated power out. There is no antenna on the 2m port. The 220 antenna performance was adequate, but had 2.4:1

SWR @ 225MHz. "Memory" button does not write the VFO contents into memory, so operation from the VFO is all that is possible.

Attempt to fix the memory button switch. If that is not possible, replace the radio with a single band 220 MHz radio from stock. However if the Memory button can be fixed, add a 2 meter antenna and coax. Connecting a 2m antenna would provide the desired frequency agile 2m radio. There appear to be spare coax runs coming into the room that could be rerouted and reused. Inspect the 220 MHz antenna and retune for minimum SWR at the middle of the 222-225 MHz band.

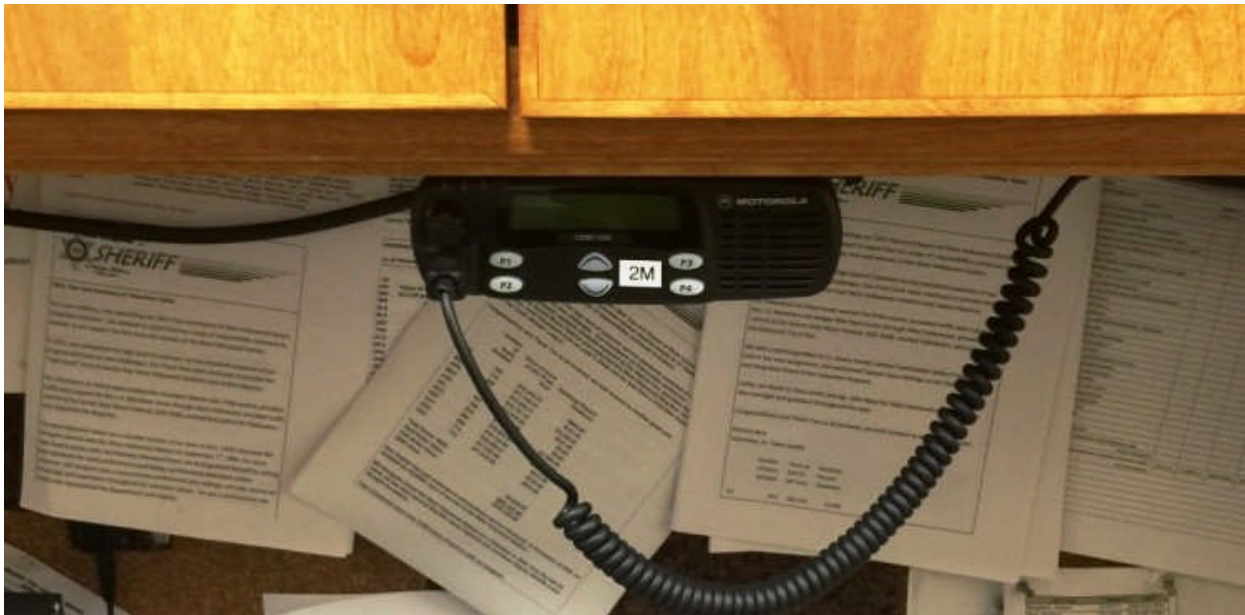
POSITION 2: Motorola CDM1250 2 meter/commercial 64 channel VHF (136-174 MHz)

Radio operates properly; rated 45w high and 25w low power output. Antenna shows 4:1 SWR on WA6ZTR input @ 147.870 MHz. Intermittent complete loss of power output with right angle BNC adapter in line. We noted that the coax braid was not soldered to connector shell. Numerous outdated / misleading frequencies are programmed in the radio.

Check antenna and coax performance. Repair or replace as necessary. Tune the antenna to the middle of the 2m band (146 MHz). Solder PL259 shell to coax braid. Load "standard" DCS code plug for CDM1250 when available.

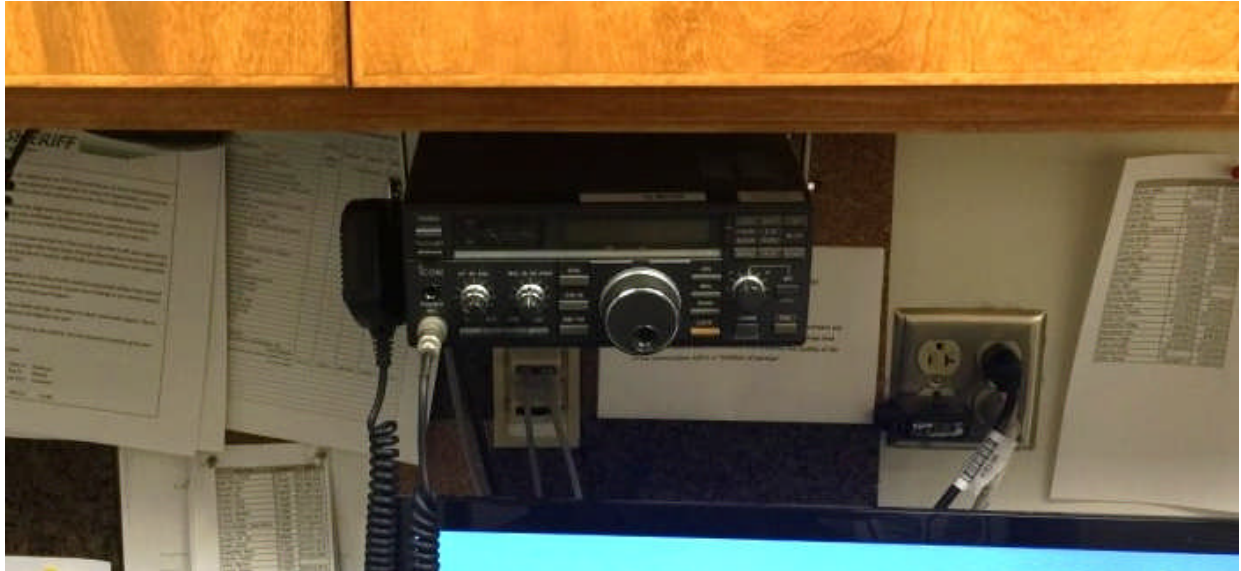
POSITION 3: Icom IC-726 HF Radio intended for 10 meter operation
LASD Inventory: 550559

Radio power output on 10m meets spec. Antenna SWR is 10:1 on 10 meters. There is a tuner cable connected for the outboard tuner but that function does not work. We could not see whether there was an external tuner at the antenna feed point on the tower. Antenna had lowest SWR around 37 MHz, so it appears to be a commercial VHF low band ground plane not cut properly. If the antenna is a commercial VHF low band ground plane, it may not be possible to extend its length enough to achieve an acceptable SWR at 29.50 MHz.

Check antenna and coax performance. If there is an external tuner on the tower such that the radio is intended to operate on all HF bands it is not working. Repair or replace as necessary.

The simplest approach is to replace the IC-726 with a Yaesu FT-8900 from stock and the appropriate antenna array for 10 and 6 meter operation.

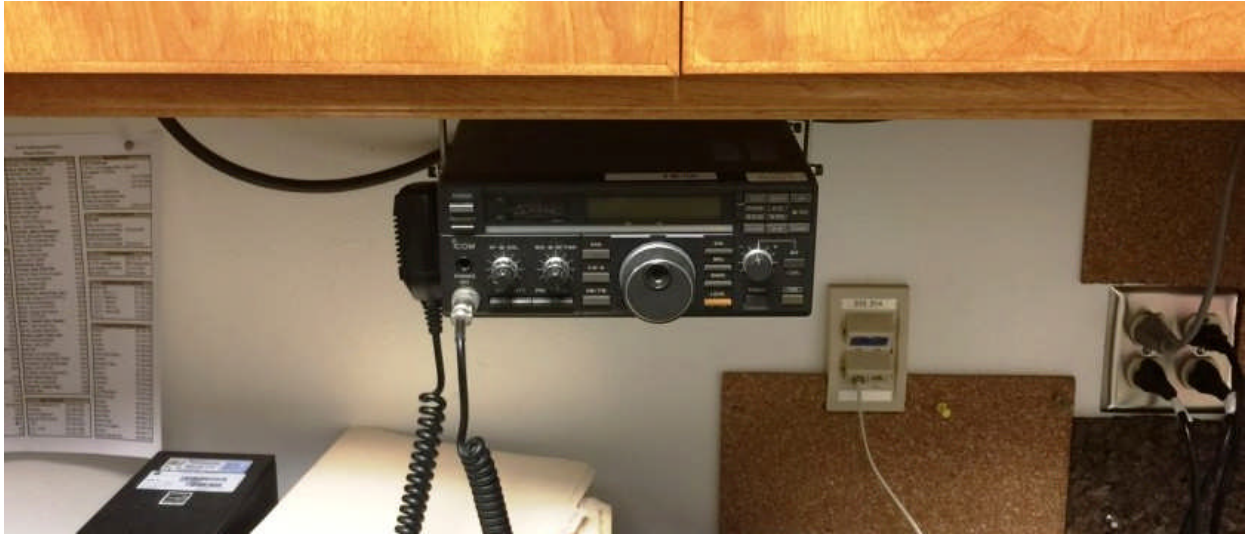
POSITION 4: Icom IC-726HF radio, intended for 6 meter operation
LASD Inventory: 550553

Measurement Results: On 6 meters the radio experienced 20dB over 9 noise level; power output was 10w however full power functions normally on 10M. Coax #5 is connected to a good 6 meter antenna; SWR @ 51.50 MHz 1.5:1. There is a tuner cable connected for the outboard tuner but that function does not work.

Resolution: Replace the IC-726 with a Yaesu FT-8900 and appropriate antenna array for 10 and 6 meter operation.

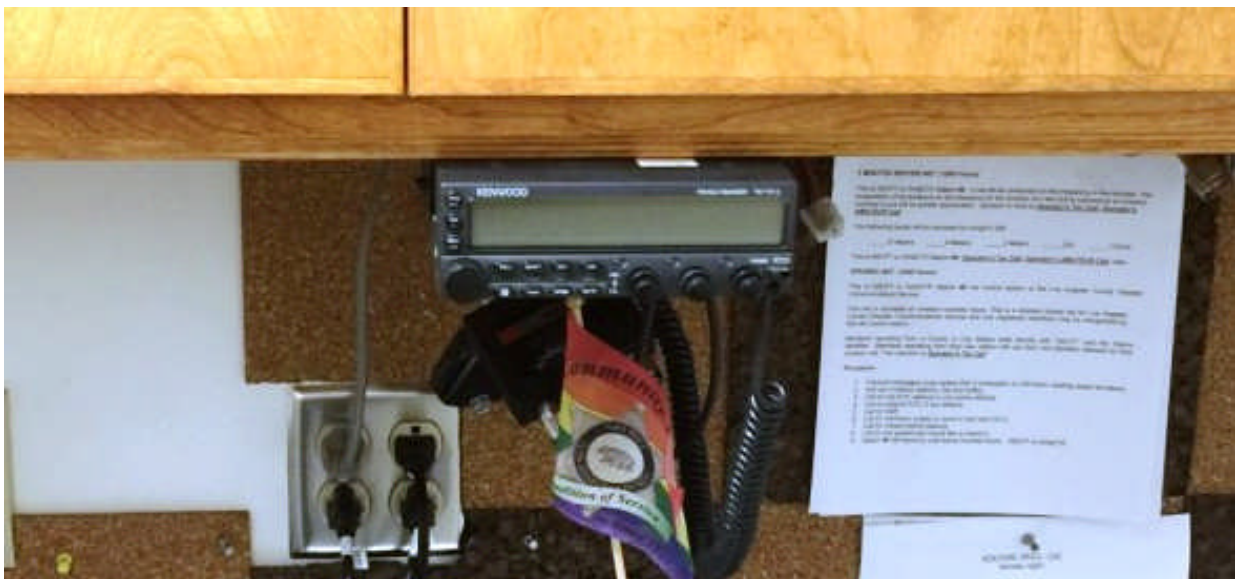
POSITION 5: Kenwood TM-741, 2M / 440Mhz
LASD Inventory: 1267

Measurement Results: The Kenwood TM741 has two RF slices, one for 2m and one for 440 MHz with an option for a third band. The radio does not power up and was

probably connected to the reported power supply that burned up. We connected the radio to the operating power supply and it still did not power up. Position 5's coax (Coax #6) would appear to be connected to a tri-band 2m/440/1.2GHz antenna since there was such a duplexer attached. The 1.2 GHz radio has subsequently been removed but the 2m and 440 ports were connected to the TM741. The antenna SWR was 5.3:1 @ 144 and 1.3:1 @ 446 MHz.

Replace with Yaesu FT-8900 and antenna complement to achieve a 4 band capability on 2m/440/6m and 10m. Consider reusing the antenna on Coax #6 as a dual band antenna for 2m and 440 (if it can be repaired) and add the dual band 6m /10m antenna and duplexer to finish the antenna complement.

Consider reusing the internal TM 741 440 MHz slice by installing it in Position 1's TM-641A. The TM741 front panel could also be used with the TM 641 to solve the Memory button problem making it a functioning tri-band 2m/220/440mhz radio. If that were to be done add a dual band antenna to Position 1 instead of the 2m single band antenna. If ISD is not interested in this project, the Technical Team could perform the operation since it is described in the users manual.
