# Trio / Kenwood TS-430S information.

# **Common faults:**

## Intermittent Drop in Power Output, Erratic ALC behaviour, SSB distortion:

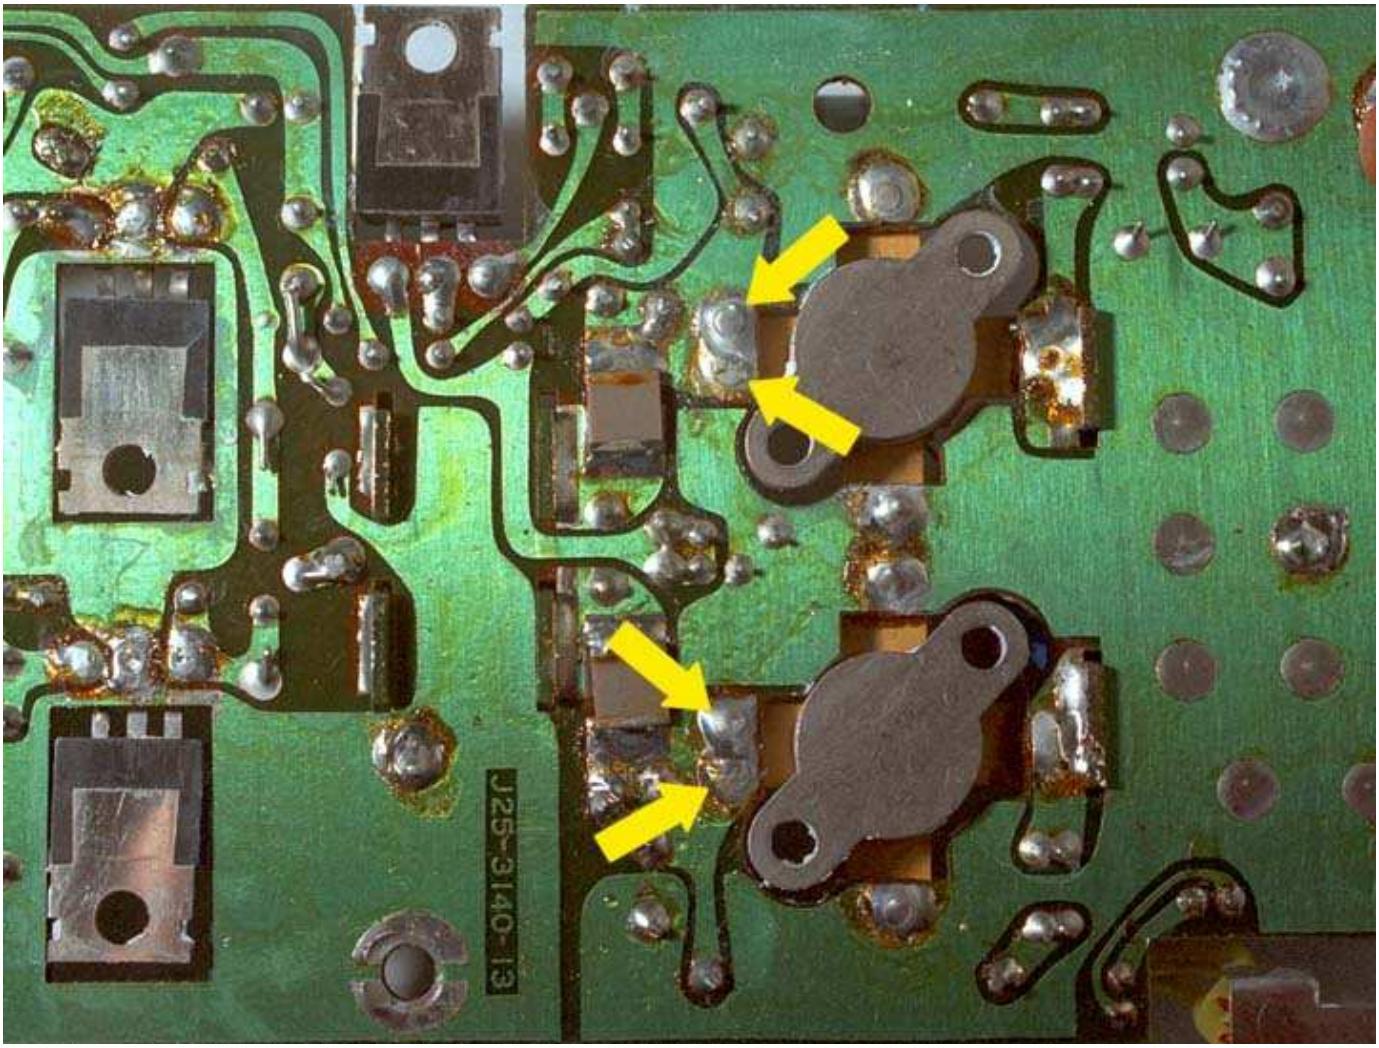
2) Remove the final amp PCB retaining screws, transistor retaining screws, and the thermistor retaining screw, and separate the board from the heat-sink. Note which transistors require mica washers, then clean off all of the old heat-sink compound with isopropanol and cotton buds. Inspect the PA transistor base via rivet heads (2 per transistor) on the underside of the PCB. A dark circle in the solder indicates that the connection has failed (even though it may exhibit a low DC resistance at the time of examination). The problem is clearly evident in the photograph below (yellow arrows), and the module shown was indeed producing distorted SSB. A cursory examination of the board also reveals failure of the emitter vias, but since the emitters are connected to the ground plane on both sides of the board, these additional failures do not prevent the unit from working.

Bridge the PA base vias with wire. This can be done without removing the transistors, by passing a wire through the gap to the side of the transistor tab. Also inspect all of the other vias on the board, particularly those at the driver transistors, and resolder as necessary.

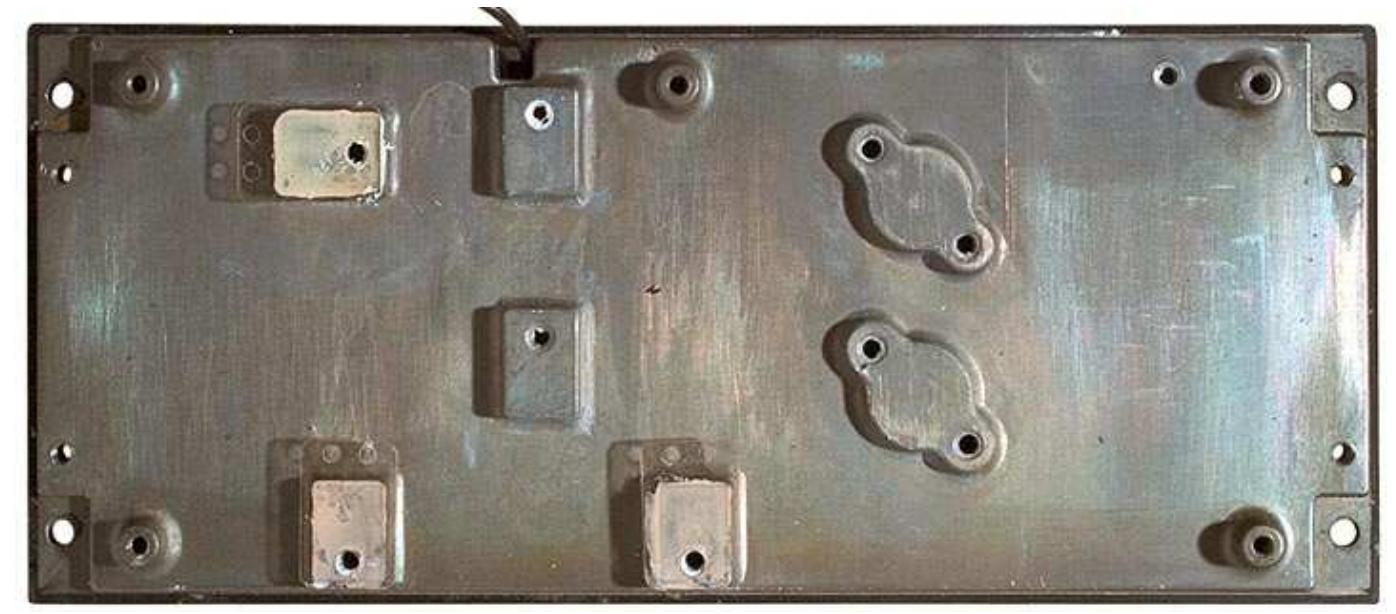
Heatsink in preparation for reassembly, showing which transistors require mica washers.

- Avoid using excess heat-sink compound.
- Do not over tighten transistor retaining screws. Leave time
- for the grease to extrude and then retighten.

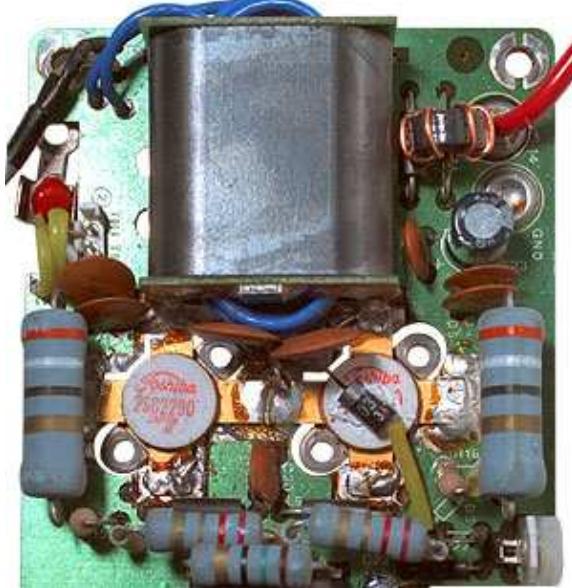
Output transformer and output transistors
