Hy-Gain AV640 (Patriot) Antenna and Guests

(Updated 06 November 2007)

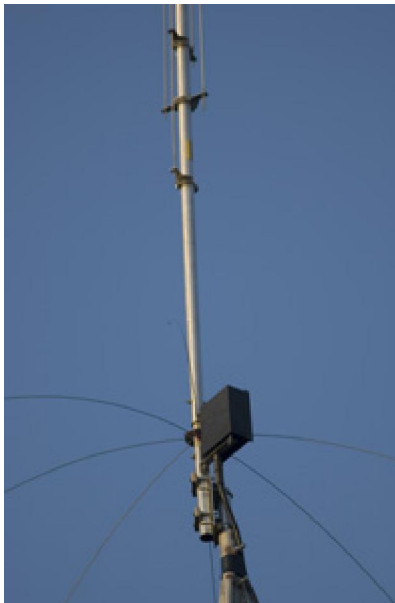
Matching network and base of stubs

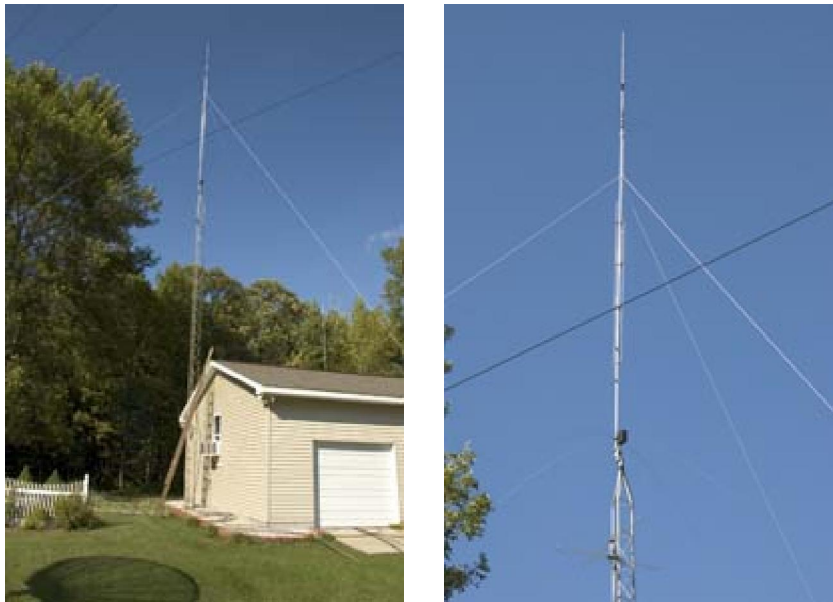
Two views of the AV-640 and tower

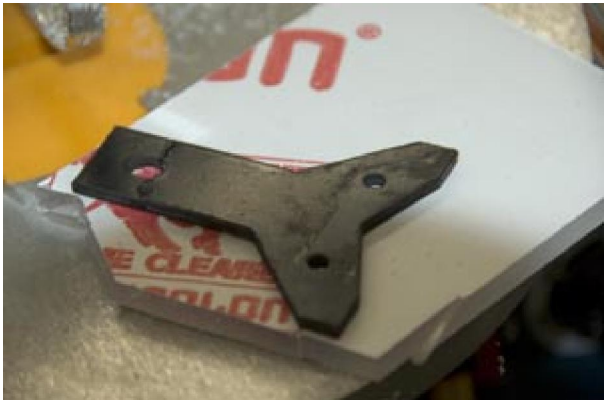
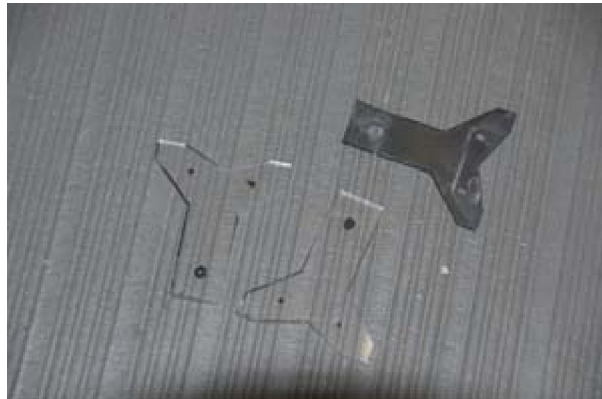
The matching network after cleaning and the broken spacer with replacements in the works.

One more time...The SWR went up and the resonant frequency for each band shifted down. Apparently a near by lightning strike took out the protective choke across the output of the matching network. The choke is clearly visible at the top of the matching network shown in the lower of the two photos of the matching network. At HyGain's suggestion I clipped the choke out and all readings went back to normal.

I disassembled the matching network and cleaned it thoroughly. The broken spacer was replaced with a piece of Lexan (TM) and the top loading coils had the connections cleaned and weatherproofed.

NOTE the spacer should be a loose fit on the stub. The AV640 is flexible. If the Lexan is a tight fit, it will grab the stub when the antenna is laid down, bending the stub and stub attach point.

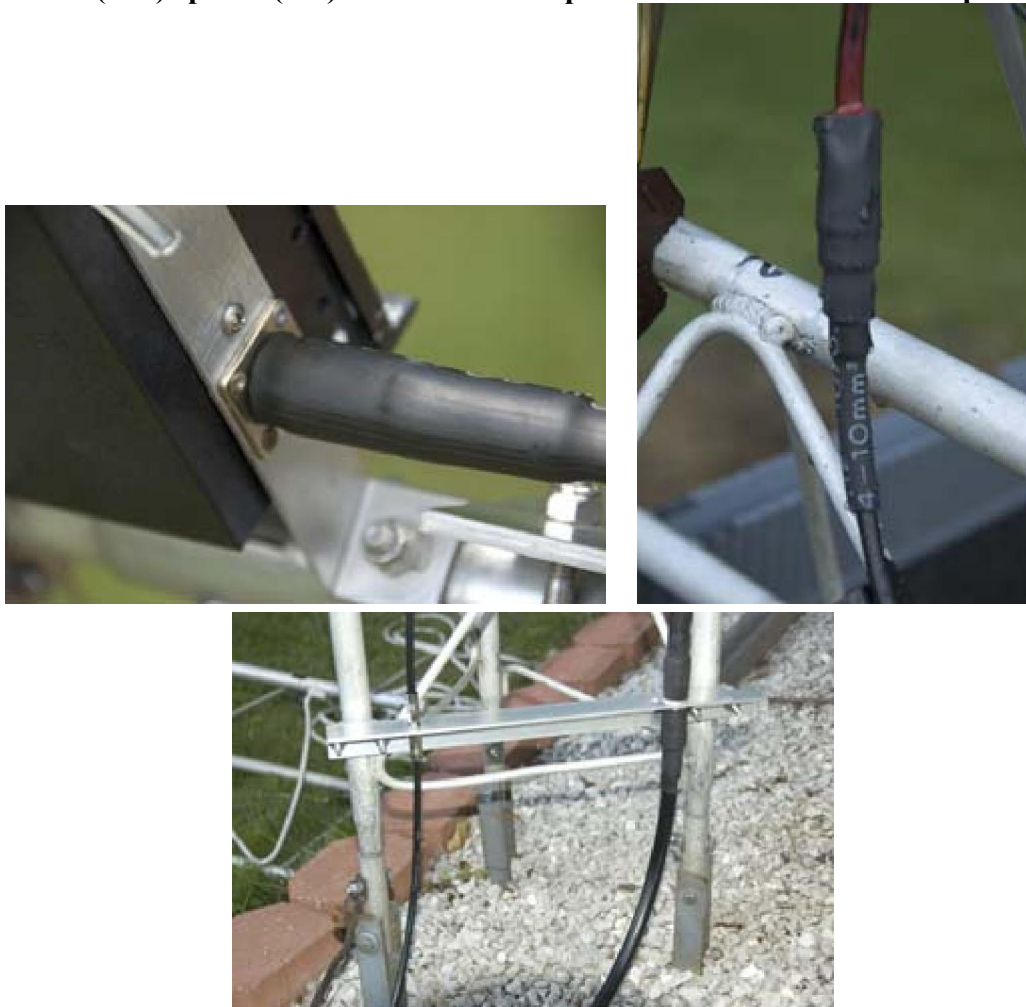
Flooded Heat shrink tubing used to weatherproof the AV-640 and TV antenna connections. Cable grounding at the tower base on the right.
