A "Silent" KWM-2A

by Ernst F. Schroeder DJ7HS

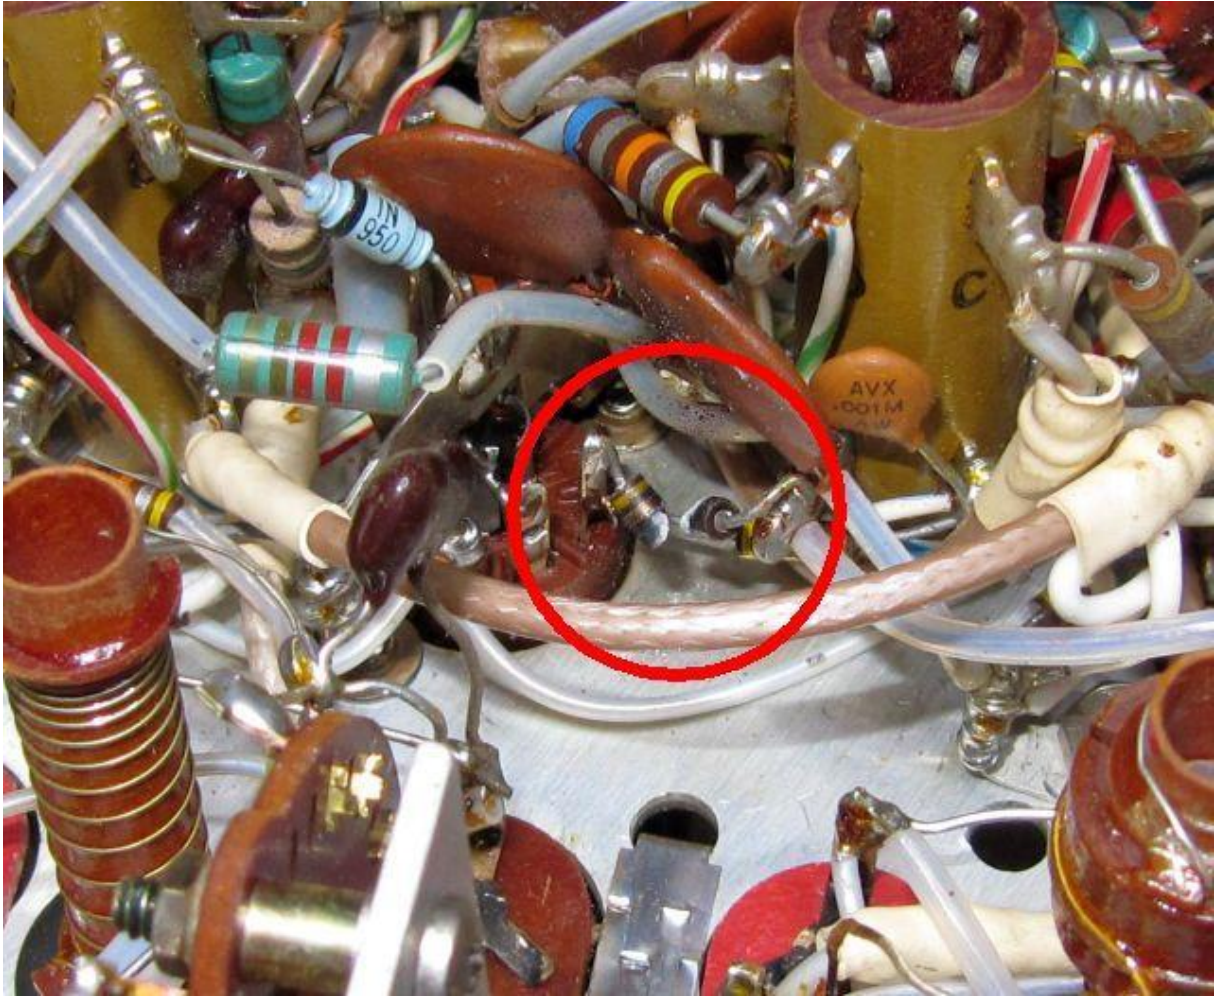
Now the KWM-2A had to come out of the box. Tracing the signal with an oscilloscope in TUNE mode showed full signal out of V6 and nearly no signal at the grid of V7. Close visual inspection was not easy in this crowded space, but it became clear that resistor R9 (56 Ohm) at the control grid of V7 was broken, literally exploded. Clearly, this explained the lack of TX drive and RX calibrator signal strength. Temporarily joining the ends with two clips seemed to restore correct operation.

It remains unclear, why this 1/10 watt resistor exploded. Neither the circuit diagram nor the surrounding parts give any clue for a cause. It can only be speculated that maybe a spurious oscillation led to an overload.

Fig. 1: The broken resistor R9 at pin 1 of V7 (RF shields removed)

The rest was easy, "only" the two inner RF shields had to come out to give access to R9 (see **Fig. 1**). The broken resistor was replaced, and now alignment was possible and luckily none of the small ceramic trimmers was "frozen". All functions were to specs.
