FT-101Z/ FT-107/ FT-707/ FT-901,902 (later version)
DISPLAY COUNTER UNIT (PB-2086A)
Custom Integrated Circuit (MSM9520RS)
Replacement Module

Assembly and Installation Manual (v1.2e)

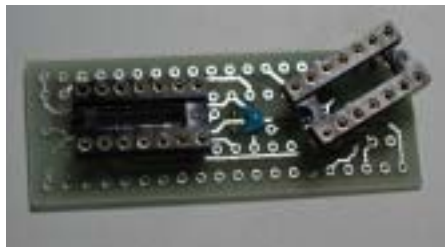
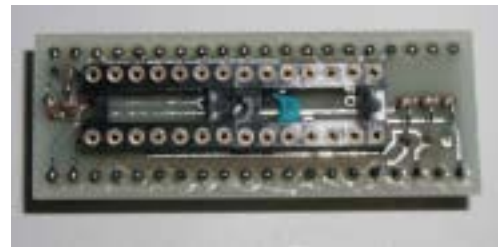
Fig. 5 TOP Side Assembly

- Assemble and solder the following parts to the TOP side of the board.
 - 1) Bypass capacitor 0.1 μ F (1 of each) for PIC 16F873.
 - 2) Pull-up resistors 10k Ω (3 of each) for the mode select logic.

- 3) Biasing resistors $39\text{k}\Omega$ (2 of each) for the input circuit of the counter. (PIC 16F873)
- 4) 28 pin DIP socket for PIC 16F873. (Use 2 of 14-pin DIP socket.)

- ◆ The 0.1 μ F bypass capacitor needs to be bended to fit under the socket.
- ◆ Use thin, pointed soldering iron to work with thin patterns and pads.
- ◆ The pads (rounded soldering patterns for parts leads) of the board are somewhat smaller to route one connecting line between 1/10 inch of DIP IC pins. Since holes of the boards are all plated conducting holes, it is advisable that the leads of parts are cut immediately at the soldering surface of the board, not bend along with the pattern, then solder the lead by “pouring” small amount of high quality solder.

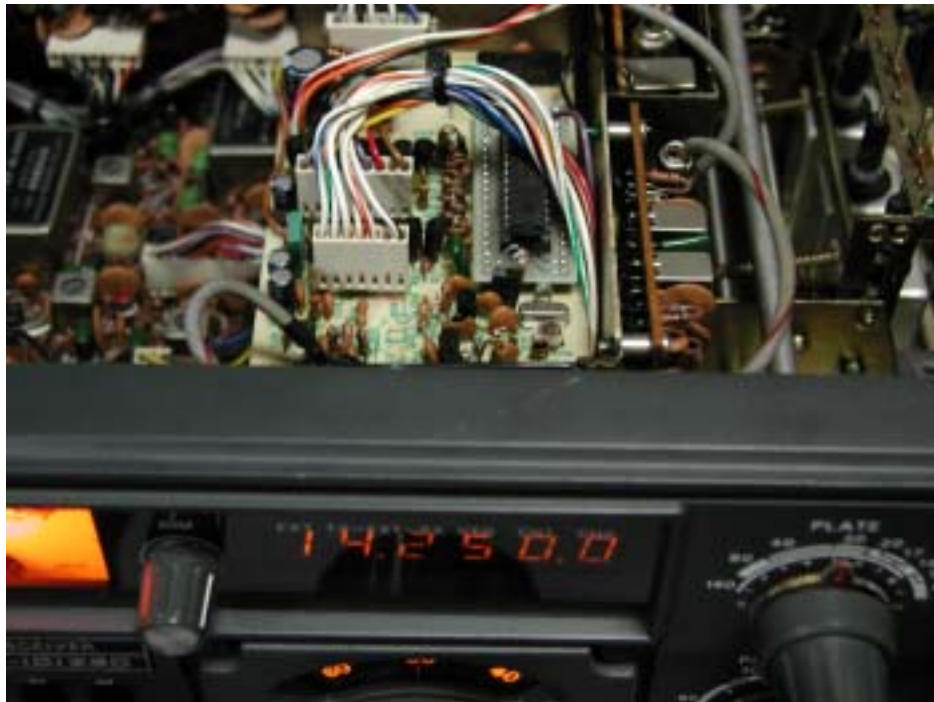
Fig. 10 Revived FT-101Z

(Step 6 - Adjustment) Receive and tune to a known frequency, (e.g. WWV at 10.0000MHz), carefully adjust the dial to zero-beat note, and then adjust TC01 so that the display shows the known frequency exactly. USB or LSB mode should be used for this adjustment. Connecting a frequency counter input to one of the crystal terminals may disturb the oscillation, therefore not recommended.
