# ETO-Alpha 89

The 89 was produced from 12/92 to 9/2000, 408 units were built during this time. These units were much like the [86](#), but with many updates and refinements.

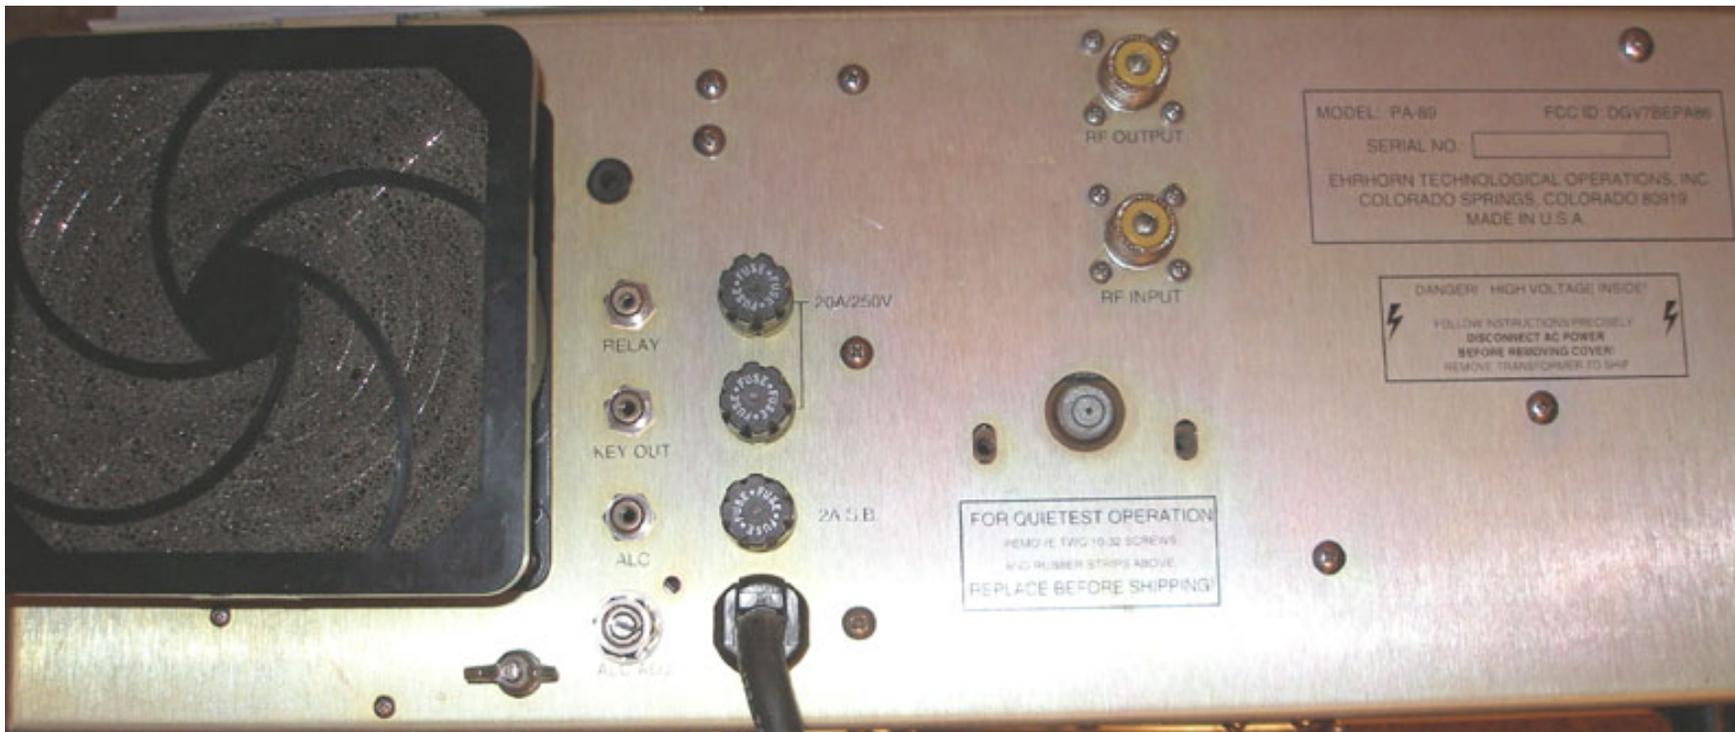
Above is a photo of the rear panel, showing the factory installed auxiliary cooling fan and washable air filter. The "key out" port is for QSK operation only, it insured proper key sequencing, and need not be used when PTT SSB is used.

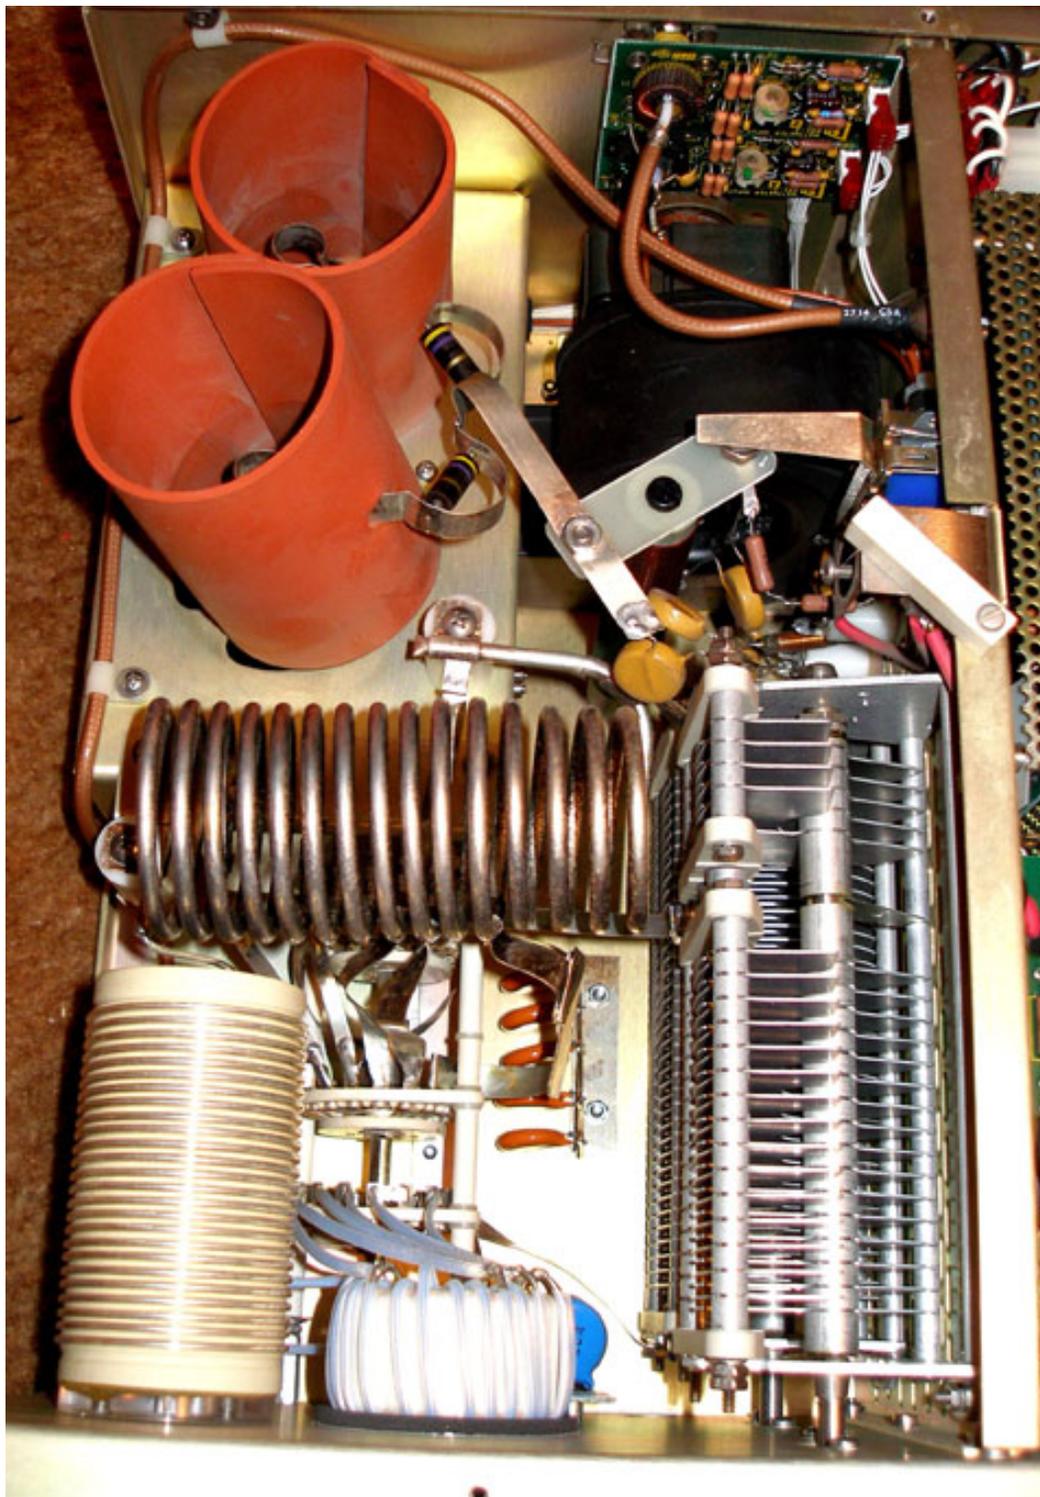
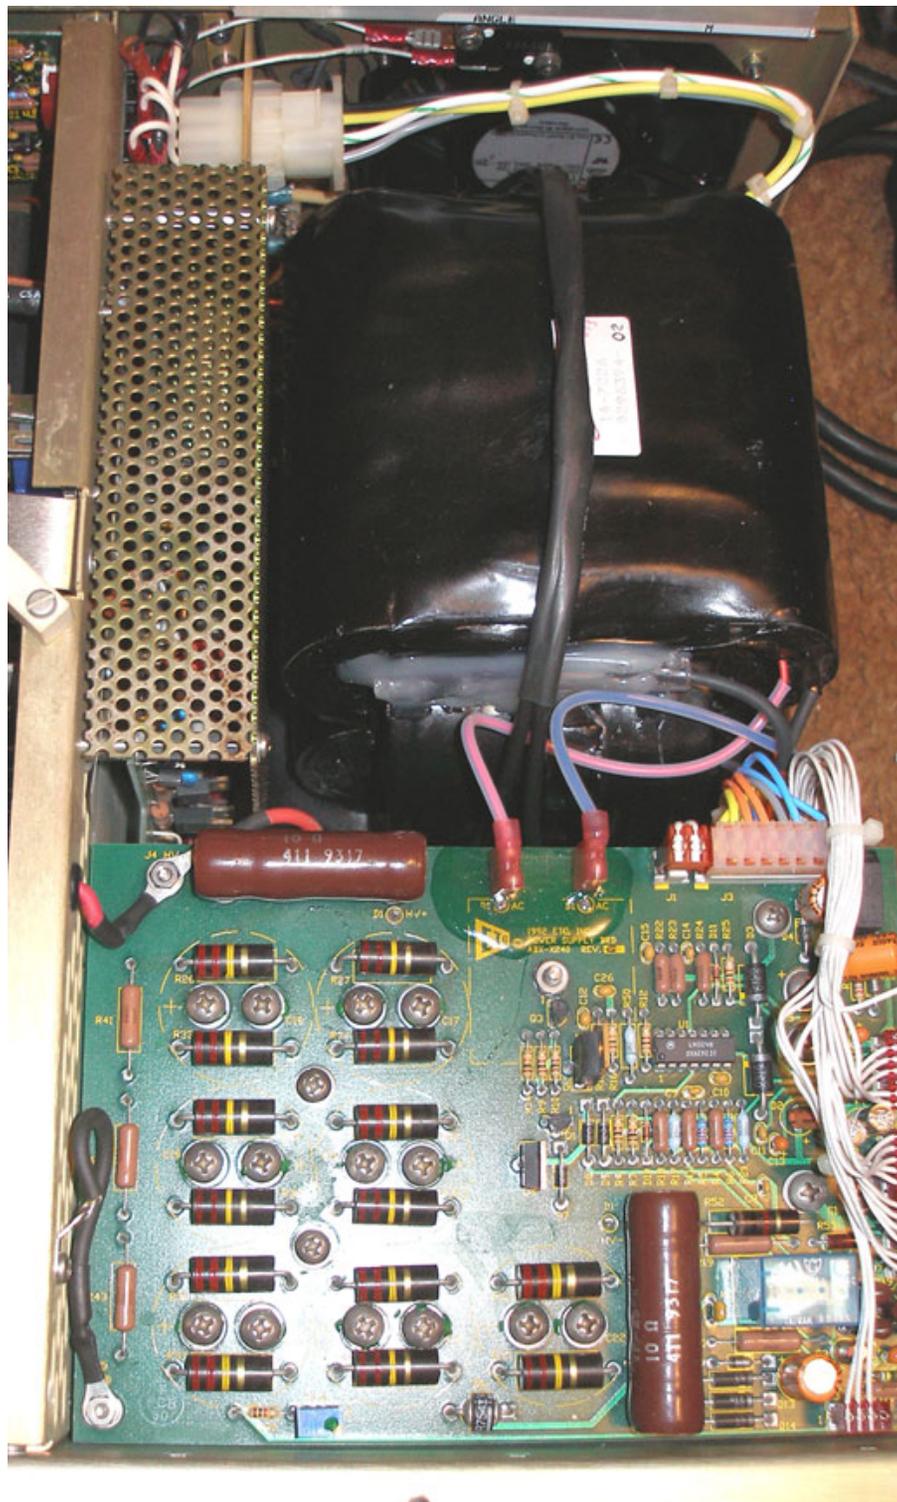
Above, you will see the RF tank section on the left and the power supply section on the right. The tube blower is the black object in the rear of the photo on the left. In the photo on the right the large black object is the main power transformer. To the left of the transformer is the T/R board. The HV rectifier is under the PCB along with the HV filter capacitors and low voltage PS.

An area to keep watch on in these amps is the connector J2 on the PS board, which is where the HV AC comes from the transformer to the rectifier. Dust and or moisture can accumulate in and under the connector and possibly cause an HV arc across it. I have encountered at least one unit where this has happened and required the total replacement of the connector and repair to the PCB as well as additional damages. If your unit has not done this, to prevent it, pull up the plastic connector header on the PCB, clean it with alcohol and apply a coating of silicone RTV and press the header back down on it, allow 24 hours for it to cure before powering up the amp. This should keep moisture out of the area between the PCB and the connector female.

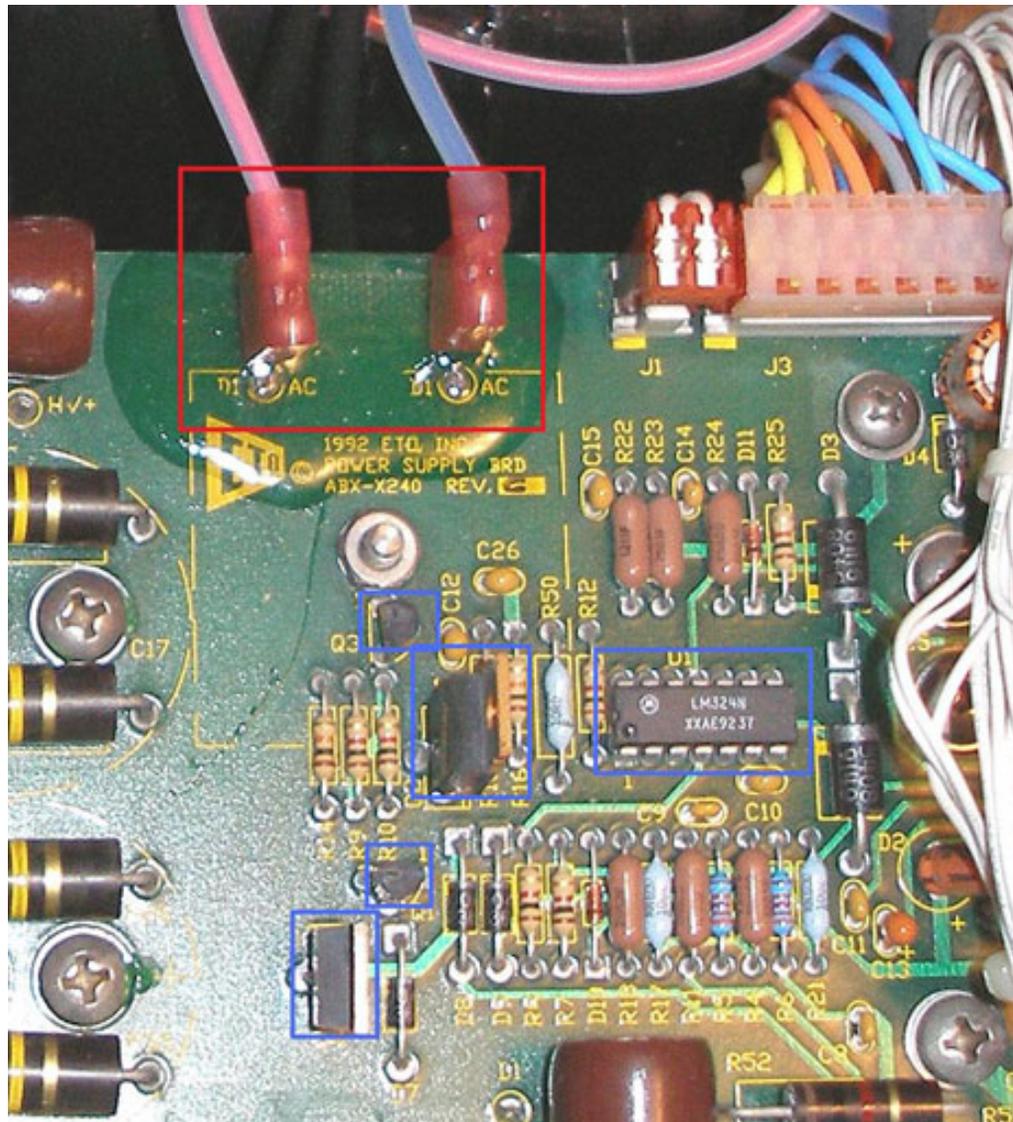
The photo above shows that damaged unit repaired. The burnt out connector was replaced with a set of vertical spade connectors and "flag" type female connectors on the wires (see red box). The PCB is cleaned of all carbon traces and sealed with epoxy cement to prevent future arcing across the PCB surface and to add strength to the connectors. The arc damaged the IC and transistors in the blues boxes (likely the magnetic pulse produced by the arc). The IC is U1 on the PS board and is the  $I_p$ ,  $I_g$ , and ALC controller, it is a quad op-amp. The small transistors amplify the  $I_p$  &  $I_g$  signals fed to U1. The large transistors are MOSFETs and are cathode bias regulators.

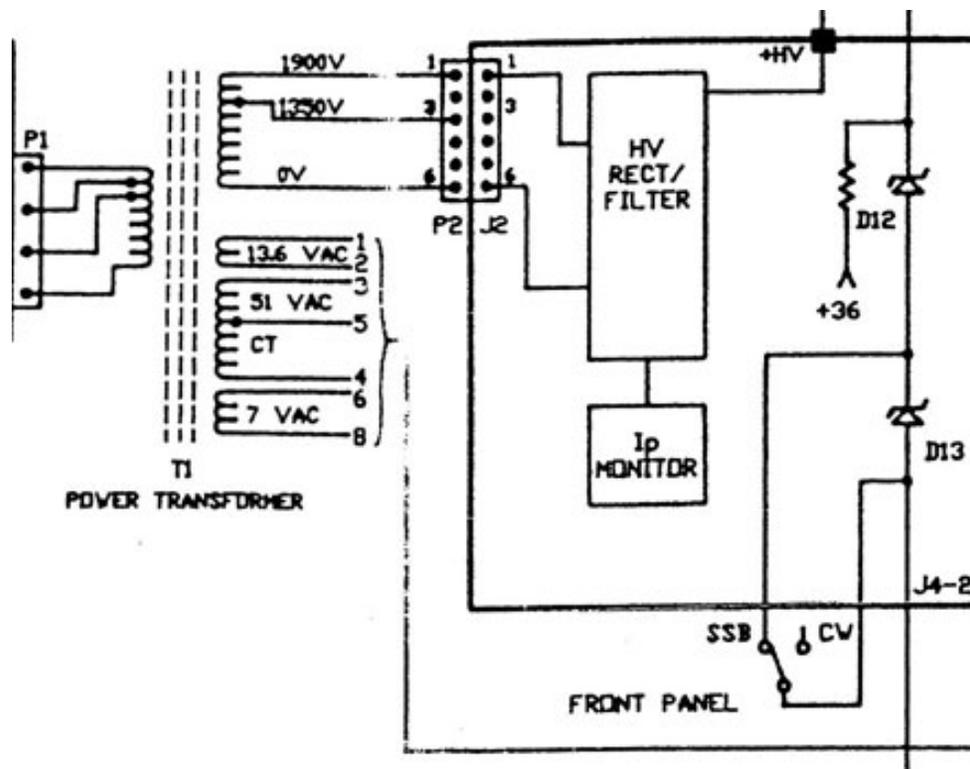
Interestingly, the 89 does not have an HV plate voltage selection like the older 86. The plate voltage is fixed, but the lower voltage is available from the transformer.

However, this feature could be added to the 89. The SSB/CW switch on the front of the 89 switches the cathode bias from class AB2 for SSB, to class B for CW/FM for better efficiency, but linearity is decreased. There are an extra unused set of contacts on this switch that can be used to operate a vacuum relay coil to switch the HV lines for these modes if the user wishes to do so. I can provide a modified schematic for this feature on request.
