# VR-002

## Vintage Radio Application Note

# RECONDITIONING AND MODERNIZING THE HEATHKIT HP-13 DC POWER SUPPLY

Rev A01/08-11/vr002\_apl\_01  
By Alex J. Burwasser  
Original Writing: August, 2011

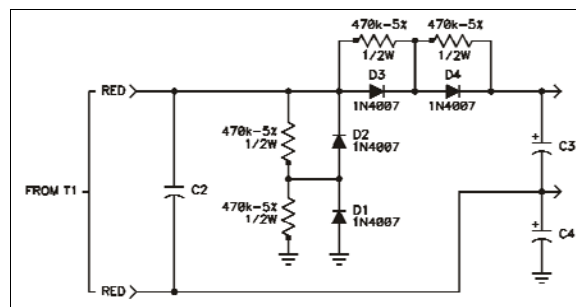
Purely from the standpoint of power dissipation, we could use 1/8 watt 5% carbon film resistors. However, resistors also have maximum voltage ratings and it would be unsafe to use a 1/8 watt resistor for this high-voltage application. 1/4 watt 5% carbon film resistors have a rated maximum working voltage of 250 VDC which would probably be adequate. However, it is better to use 1/2 watt 5% carbon film resistors with their higher rated maximum working voltage of 350 VDC. The modified diode section of the full-wave voltage doubler is illustrated in Figure 2.

**Figure 2 - Full-Wave Voltage Doubler  
Modified to Include 1N4007 Silicon Diodes  
and Shunt Voltage Equalizing Resistors**

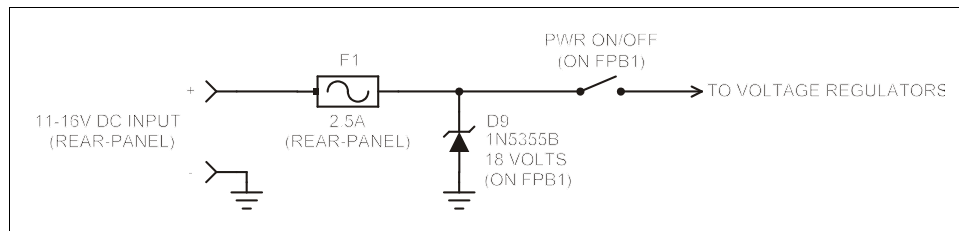
An apparent HP-13 design shortcoming is that it has neither over-voltage nor reverse-polarity protection at its 12 VDC input. This was remedied by adding a single Zener protection diode.

**Figure 9 - Over-Voltage and Reverse Polarity Protection Circuitry**

The operation of this protection diode can best be explained by examining an actual circuit where it has been successfully employed. Figure 9 is a simplified schematic of the input power circuitry of the RDF Products DFP-1000A DF bearing processor (the predecessor to the current DFP-1000B). The following detailed explanation of this circuit is an excerpt (with some minor paraphrasing) from the DFP-1000B Service manual:

I strongly recommend adding this inexpensive part to the HP-13. Referring to the HP-13 schematic of Figure 1, the 1N5355B cathode be connected to the positive terminal of C6 (i.e., at the power transformer center tap) and the anode should be connected to ground.
