## Butternut HF6V vertical antenna repair

Klaus illhardt  
VK3IU

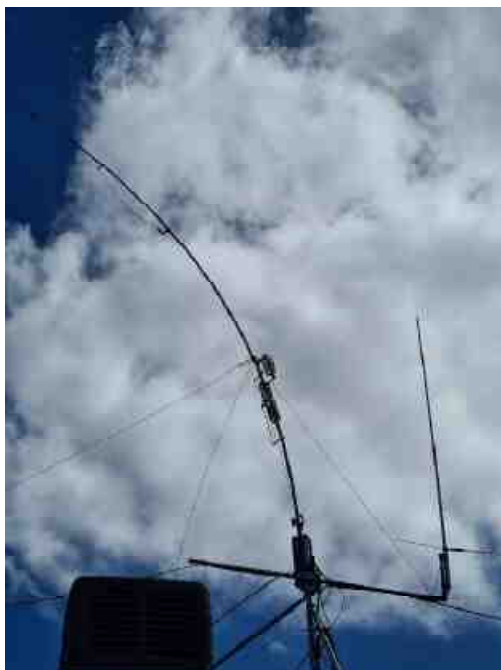
The Butternut HF6V is installed on top of my two-story home and my QTH is located on a small hill, therefore the antenna experiences frequent strong wind gusts. I also guyed the antenna over the 30m coil as recommended by Butternut.

During one of the strong winds

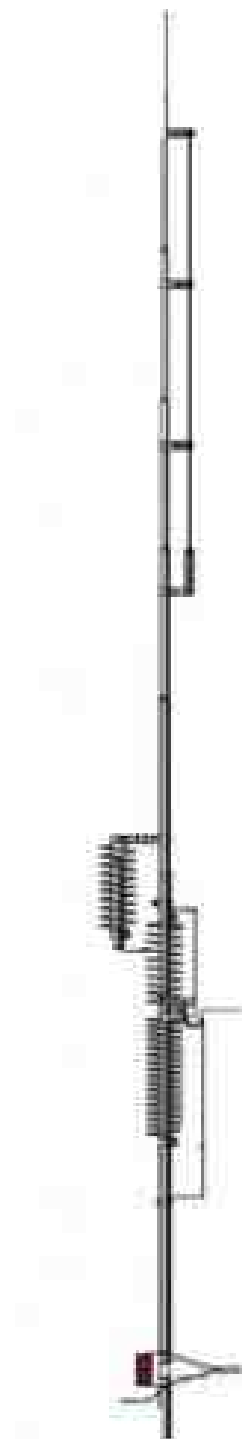
Based on the build of the Butternut HF6V my suspicion fell immediately on the 30m assembly of the antenna which influenced the 20m and 30m band. I posted a description of my problem in the forum of eHAM.COM and got a lot of good replies which lead me to believe that the culprit is very likely the 68pf doorknob capacitor of the 30m assembly.
