Tempo 2020 Sprocket Repair Ted Bruce, KX4OM March 2009

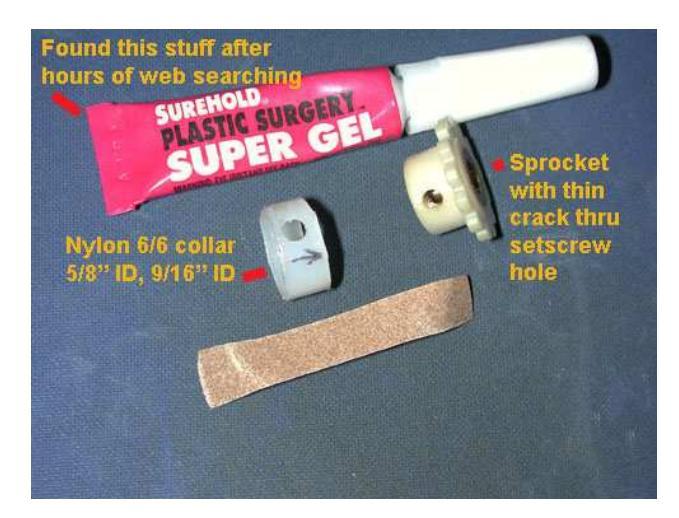
Photo 1

- 6. Compare the newly-made nylon collar with the sprocket to make sure that the set screw hole will be accessible after assembly. *See accompanying Photo 1* on the last page.

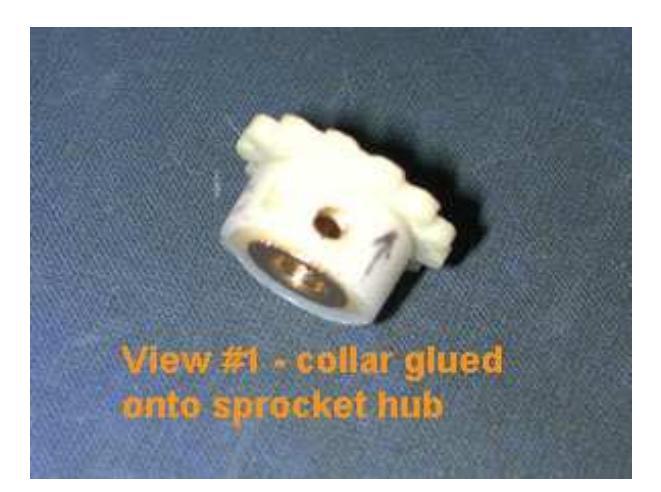
- 11. Quickly line up the collar with the hub and push it all the way on. *See accompanying Photo 2 and Photo 3.*
- 12. The glue quick-sets in a few seconds, but fully sets in 24 hours.
