The IC-4KL HF solid-state 1kW amplifier.

By Matt Erickson, KK5DR

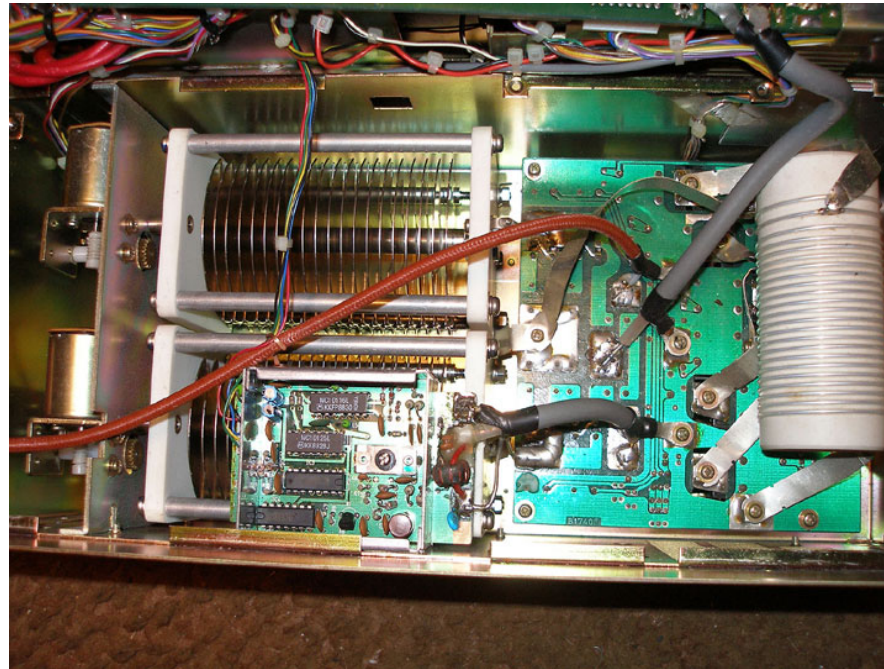
The Automatic Tuning Unit uses relay-switched inductor and two servo-motor driven air variable capacitors, in a T-network. There are additional relay switched capacitors which are used when the amp is operated on the 1.8MHz band, the caps are switched out on all other bands.

The tuning unit is designed to handle a maximum SWR of 3:1 or 16.7 to 150 ohms. It has an insertion loss of 0.5dB after tuning, which means that at 1kW output there will be a fair amount of heat will be generated in the ATU. For this reason there is a fan installed to draw cooling air through the ATU. This is a small "muffin" fan that cools the ATU section. During ATU operation at 1kW output into an SWR of 3:1, there is a significant amount of heat that will be dissipated in the ATU circuits, so cooling air is needed.

Should your 4KL fail to recall tuner settings, this usually means that the back-up battery is depleted and needs replacement. This is likely to happen about every ten years. If the battery voltage reads 3Vdc or more, it is fine, check it again in a few years.

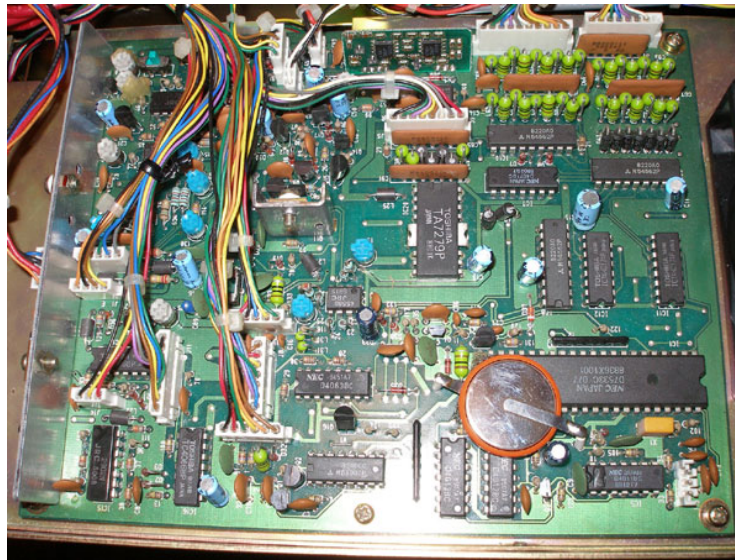
Above, you see the main control board where the CPU can be found, under the back-up battery (orange & silver round part).

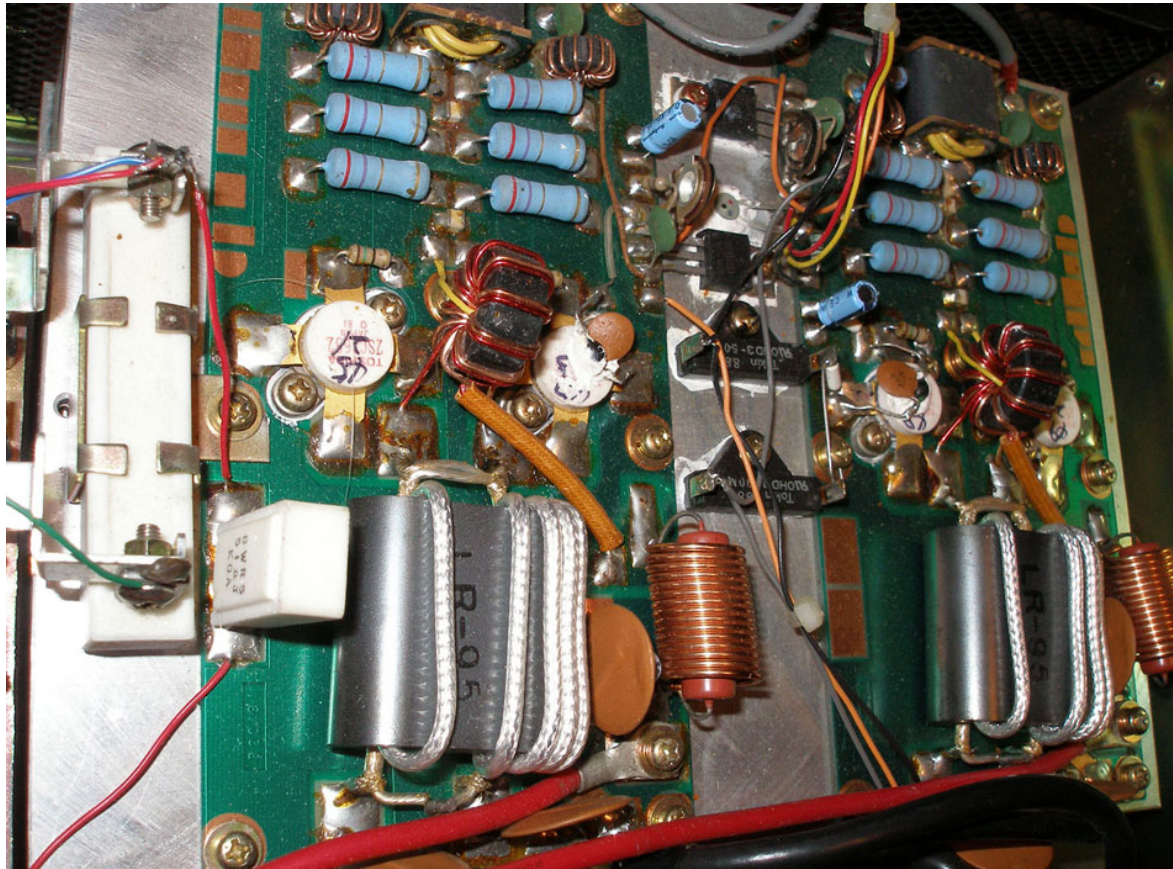
The photo above shows two of the four PA modules with their input and output transformers. The black objects in the center are the temperature sensors that sense heat-sink temp to activate blowers, and protective circuits. The other two modules are on the opposite side of the heat-sink. The design of the heat-sink is a "flow-through" cooling system, small but very efficient. Forced air goes through the heat-sink and exits the rear of the RF deck.

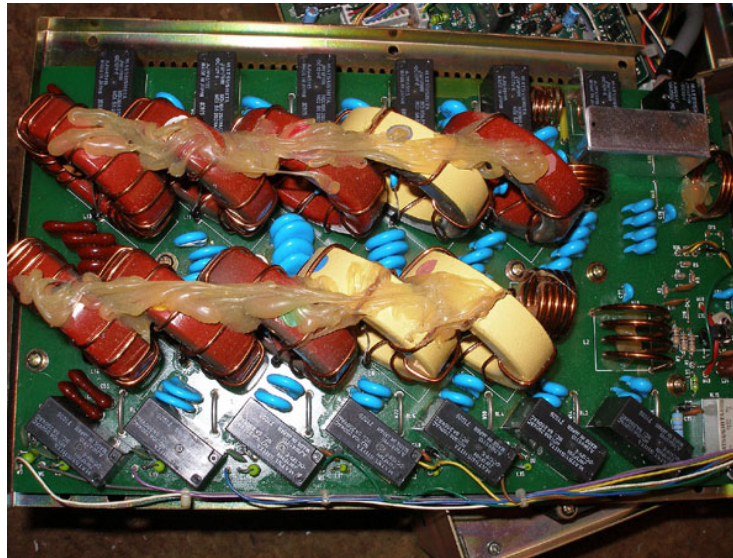
Broad-band amplifiers require a set of low-pass filters to attenuate harmonics. Below is a photo of the LPF section.

Each filter section is selected by the CPU based on band of operation, through relays. These coils are quite large, about 2" in diameter.

(3) Check the filter PCB for cracked or "cold" solder joints; if in doubt re-flow the solder connection.

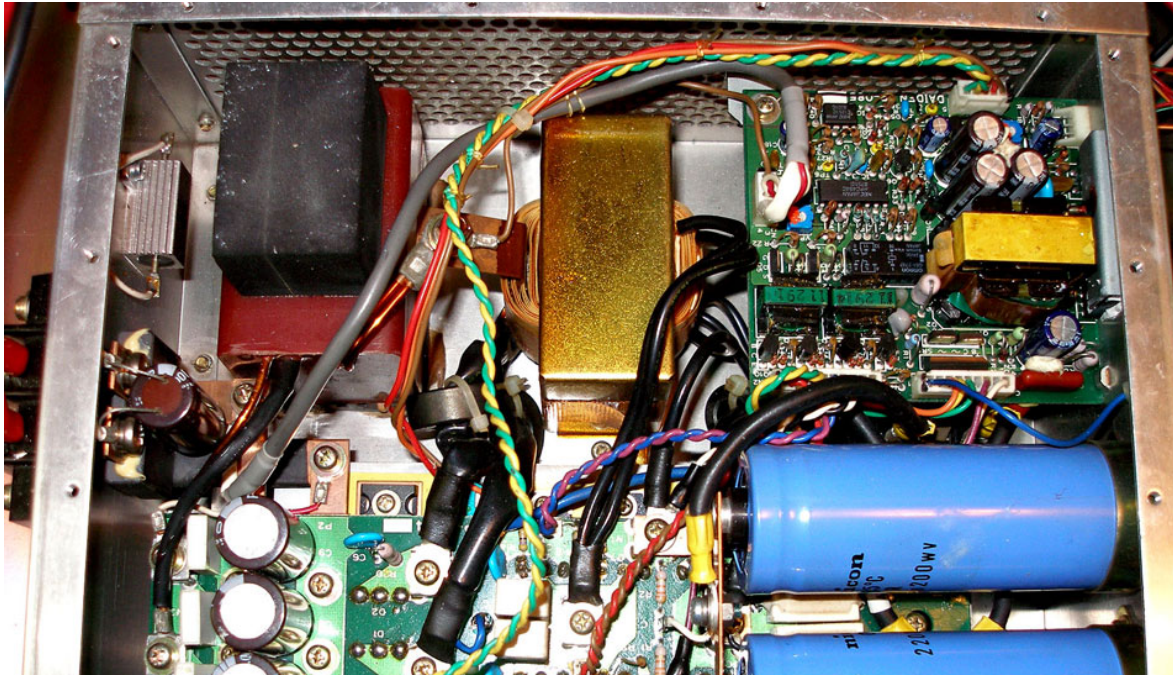
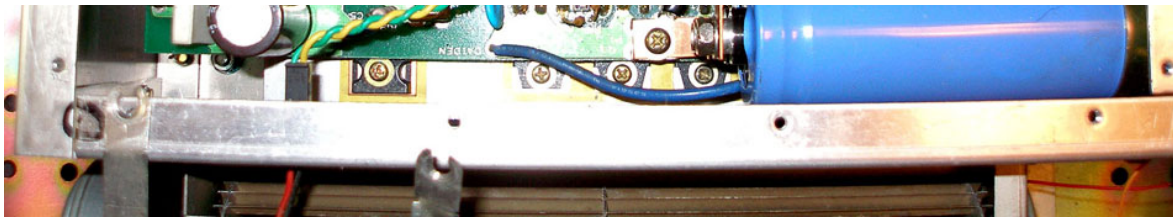
The PSU is shown above. This is the OEM +40Vdc @ 60A. switched-mode power supply. No schematics exist for this unit (EP102), there would be virtually no way to fix it. There is a separate DC to DC converter unit that converts the +40Vdc provided by the main PSU (EP102) into + & - 13.8Vdc which is converted to +/- 5Vdc by regulators on the main board. A photo of the converter is shown below. This converter is the same type as used in the IC-2KL and AT-500.

(5) Check the large high-voltage filter capacitors in the PSU for evidence of leakage (whitish crystalline deposits around the vent port in the rubber plug), and replace as needed. If the rubber plug in the end of the cap has blisters in it, replace the cap.

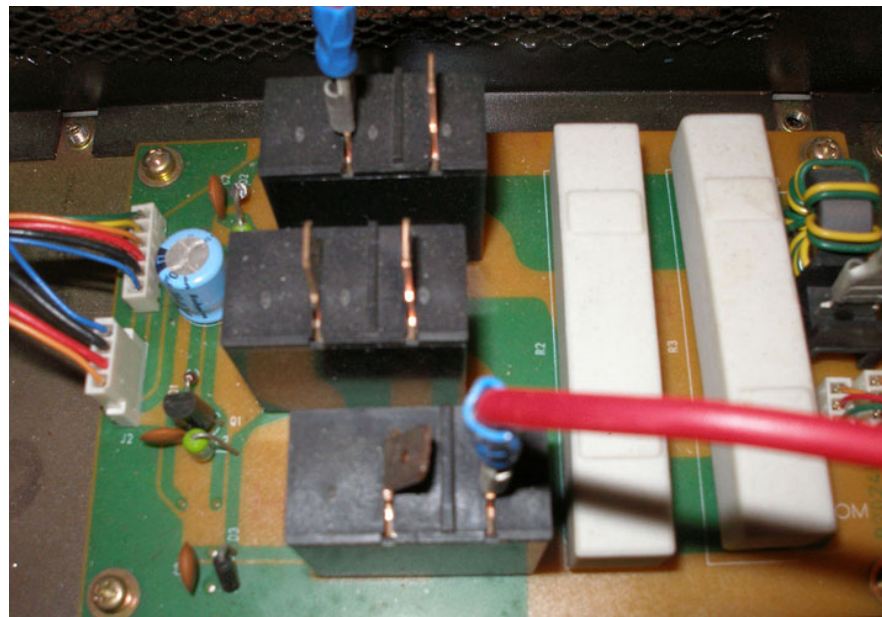
The photo above shows the REG unit which switches automatically from 120Vac to 240Vac. It also acts as a "step-start" module.

(1) Check the REG unit for evidence component heating. Since this unit is "on all the time" whenever the AC mains are connected, and the breakers are <ON>, the heat dissipated by the board components can de-solder some of the PCB connections over time. The connections should be re-soldered. A better solution is to replace the parts that overheat with parts having a higher dissipation rating. A good interim procedure would be to place the breakers in the <OFF> position whenever the amp is not in use.

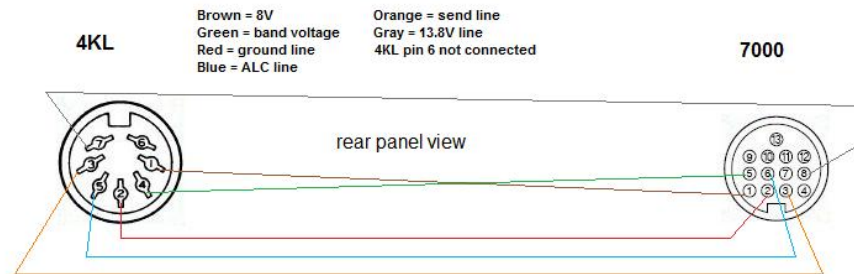
I have drawn up simple DIN to DIN cable interface(s) for various ICOM exciters. The 13 pin IC-7000 is given as an example and should be the same for all ICOMs with 13pin DIN ACC plugs, such as the 718, 706 series, and 703. However verify the connection prior to using the cable.

The interface cable for all other ICOM radios with a 7 pin DIN ACC plug are the same as that of the 4KL, the pin/color key above can be used to construct your own cable.

It is important that you use only the 7 pin DIN (on the exciter) for this interface. The 8 pin DIN is not entirely wired properly, and the amp will not function properly. The correct configuration is 7 to 7, or 7 to 13 for all ICOM radios. **Do not** use the 8 pin DIN (on the exciter) to connect to the 4KL! There are only 7 pin DIN connectors on the amp.

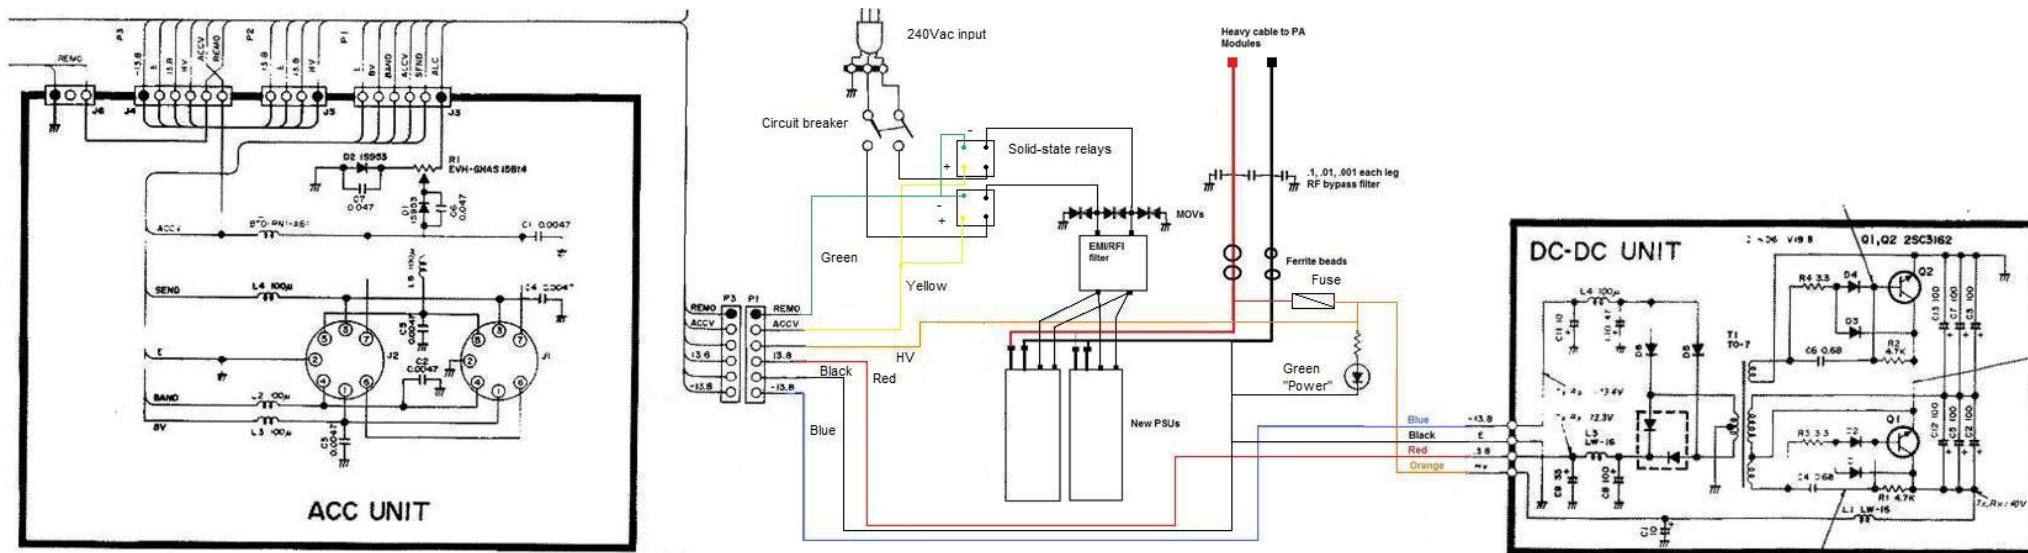
Below is a basic schematic showing the interface of the new PSU. It is a mix of the original schematic and the new circuit integration I have designed.

The theory of operation of the new PSU is; ACCV/ $+13.8\text{Vdc}$ from the exciter is fed to the control circuit of each of a pair of 240Vac @ 25A solid-state relays (Opto-22 model 240D25), when the <Power> switch on the 4KL control head is pressed in, the circuit is grounded and activates the relays. This causes the PSUs to power up providing 40Vdc/HV to the DC to DC converter and to the PA modules. The 40V provided to the converter is converted to $\pm 13.8\text{Vdc}$ which is provided to the main PCB where it is converted to $\pm 5\text{Vdc}$ for the IC circuitry. During power-up, if the PSU is operating normally the Green "Power" LED will be lit. There are circuits in these PSU modules for external alarm indicator but I will not use them for now. These PSU modules are fully automated and protect themselves very well. The output of these PSUs can be remotely controlled by an external switch or relay contact connected to the proper pins of the unit. The input of the PSU is **NOT** controlled by this switch, so it will run as long as AC voltage is connected.

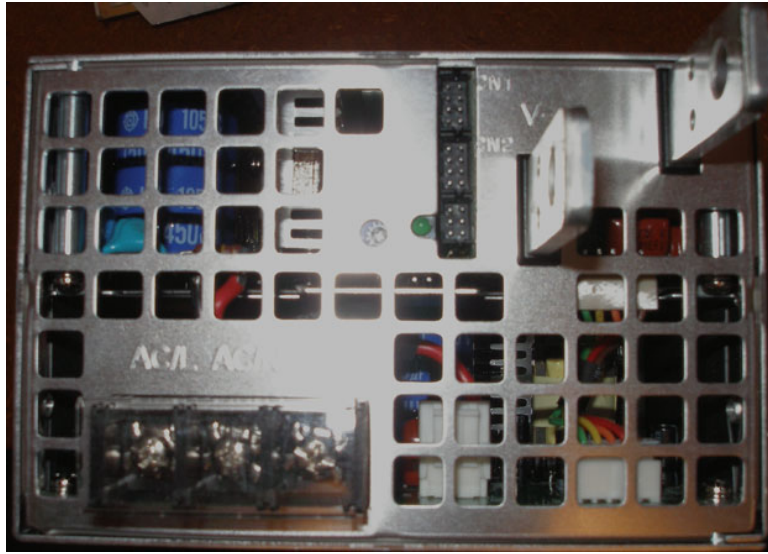
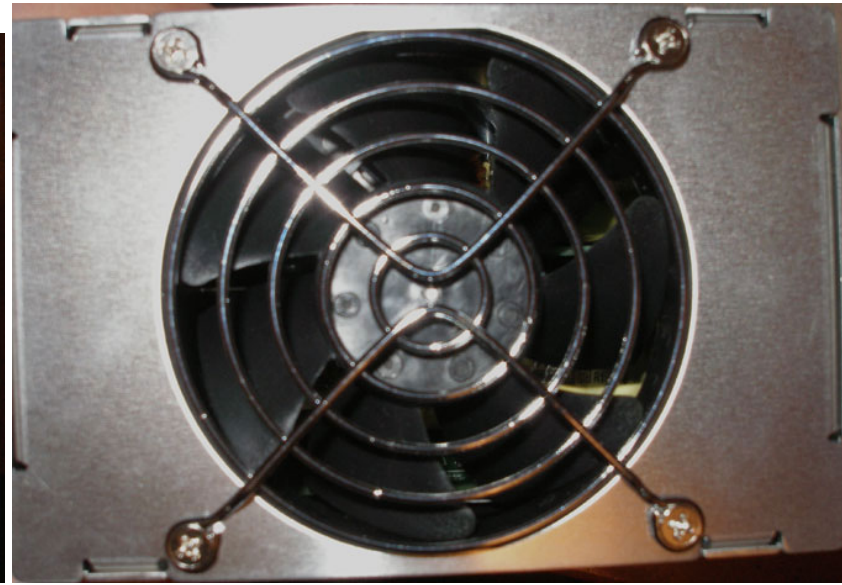
The photos above show the end views of the new PSUs, the photo on the left shows the AC input/DC output end of the PSU. The photo on the right shows the cooling fan (3" dia.). Cooling air is drawn in this end, and exhausted from the input/output control end. You will notice that there are a set of connector pin sockets on the control end of the PSU; the connectors for these are special 2mm pitch type. The PN for each from [Mouser](#) are; [855-M22-3020300](#) (2 req.), [855-M22-3020400](#) (4 req.), and the pin clips are [855-M22-3050042](#) (at least 20 are required.). All these cost about \$5.50 plus shipping. Specific wiring details are shown on the [data sheet](#) for these units. Unfortunately the clips do not grasp the pins very well since the clips are made for square pins and the pins on these PSUs are round. So, I had the tedious task of carefully crimping the clips so that they will grasp the pins better, at best they are still rather delicate. I could not find a source for the round pin clips. Care should be exercised with this control wire harness, it is not retained very well, so it would be easy to knock loose, the harness should be tied down to help prevent this.

The new switching PSU I am using is the [Mean Well® RPS-1500-48](#) which can current-share in a master/slave configuration. It is important that both units be adjusted to within 100mV of a volt of each other for current sharing. Voltage is externally adjustable from 70-100% of the full 48Vdc, or down to 38Vdc. I found that the built-in voltage trimmers can adjust down to 40V very easy. I set both units to 41.01Vdc each, to allow for voltage drop from the PSU to the PA terminals. The trimmers are a little hard to adjust with precision due to the small size, but should be set as close to each other as possible. An external trimmer would allow more precision and range to the adjustment, but are not needed for this application since these are "set and forget" adjustments.

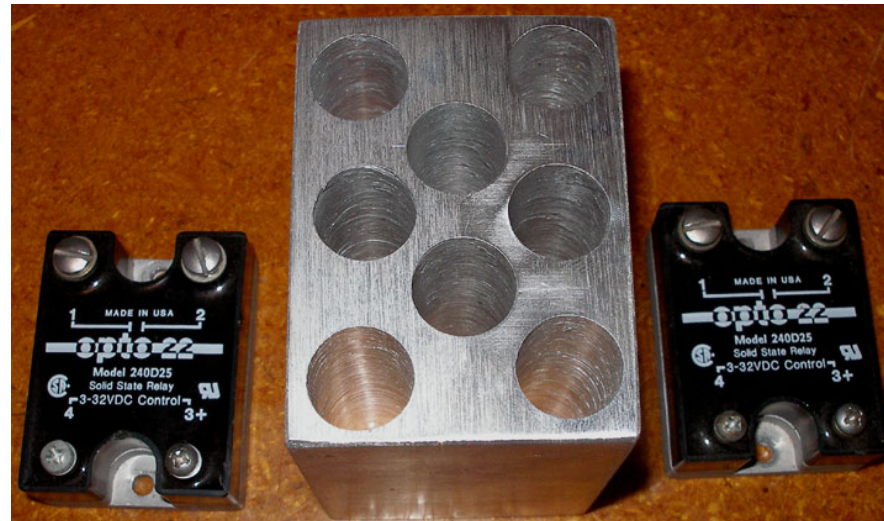
Most AC solid-state relays have a voltage drop across them and therefore heat dissipation, so a heat-sink should be used if that level is over a few watts. The relays I am using have a 1.6V drop at 25A load, which is about 25 watts of heat. Since there are two units I have 50 watts of heat to get rid of. Below is a photo of the relays and the heat-sink I fabricated for the job.

The heat-sink is made from a solid block of aircraft aluminum, with through holes drilled to produce a "block-o'-cheese" type sink. The purpose for this design is for PSU fan blown air to flow through and remove the built up heat. The relays will be mounted to each side of the block, and the block will be mounted to the deck of the 4KL PSU bay. Thermal grease will help transfer the heat from the relays into the block.

A standard open-frame relay could be used for this circuit, but the coil current would be much higher. The Opto-22 relays have a control current of about 10mA at 12Vdc, so the total current will be about 20mA on the remote line through the <power> switch in the control head of the 4KL. A few of my reasons for using this type of relay are; (1) Ultra low control current draw. (2) Wide range of control voltage. (3) Zero-crossing start up, which controls "in-rush" current. (4) Totally silent operation. (5) I had them in my stock pile of parts. The primary drawback is that they have a voltage drop and heat output. I am willing to live with that.

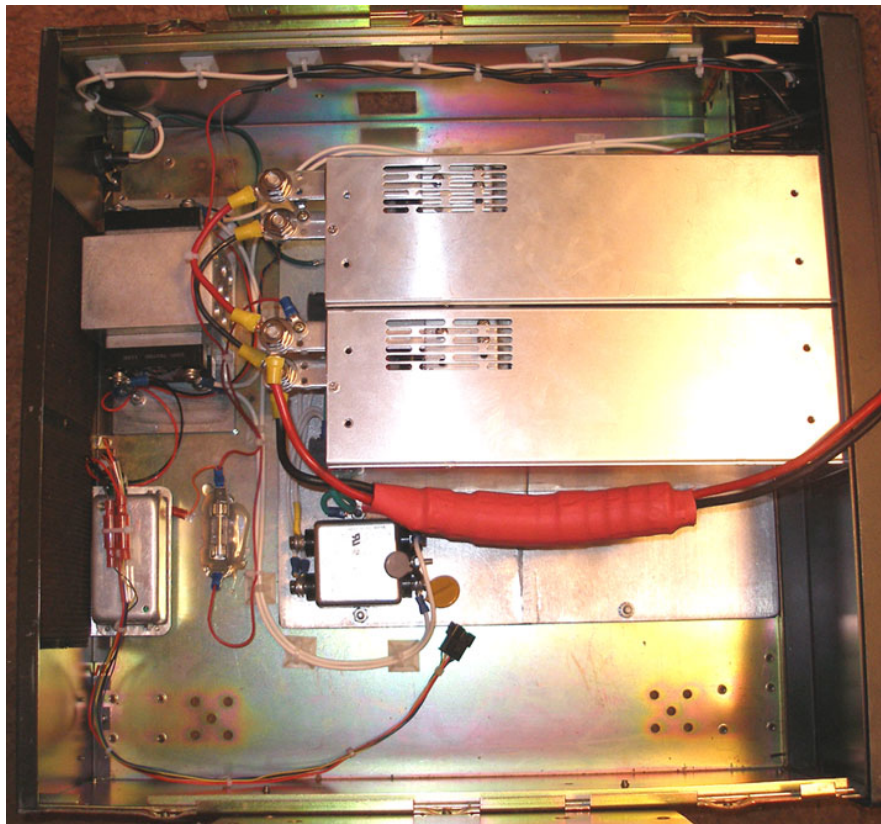
The photo above shows the new PSU modules installed in the PSU bay of the 4KL. The mounting plate allows the use of the original PSU mounting holes through the bottom. The reason for the positioning of the modules is to have the cooling air intake align with the air intake filter of the 4KL PSU bay.

AC mains power enters the bay at the upper left of the photo, passes to the main two pole circuit breaker on the front panel, then is routed to the EMI/RFI filter module seen at the lower center of the photo. Separate line feeds go to both PSU modules from the EMI/RFI filter output. You will notice a set of three MOV voltage surge suppressors are mounted on the input side of the filter, these were salvaged from the original PSU. The yellow MOVs are 130Vac type from each line to chassis ground. The gray MOV is a 275Vac type across the AC main lines. I have designed this system to operate only on single phase 240Vac, 120Vac would not be an efficient way to operate this system because the AC line voltage drop would be too great. This would affect regulation and possibly cause the PSU to shut down due to low AC input voltage at full load (32A.), which switching PSUs really do not like.

You will notice two things from the photo above: First you will notice that there is a large red heat-shrink sleeve on the main DC power cables. Originally there were two black-mix ferrite sleeves on the cables, I added nine more of gray, red and yellow mixes, to cover all frequencies and eliminate the possibility of any RF making it back to the PSU DC outputs, then I placed heat-shrink tubing over them to prevent movement and protect them from damage. Next, you will notice the fuse holder just to the left of the EMI/RFI filter which I added for protection of the DC-to-DC converter unit. Should there be too much current drawn from this unit for any reason, the fuse will protect it from serious damage. The fuse installed is a 1.5A. fast blow type, which seems high enough.

The <Power> LED on the front panel of the main unit lights when DC power is available. The LED is on the output side of the fuse, so if the LED goes dark, but the PSU fans still run, the operator will know that the fuse is open. The <Overload> LED is not connected at this time, but is present in the front panel.
