| Title Exciter Modulator & Quadrature Divider | | |

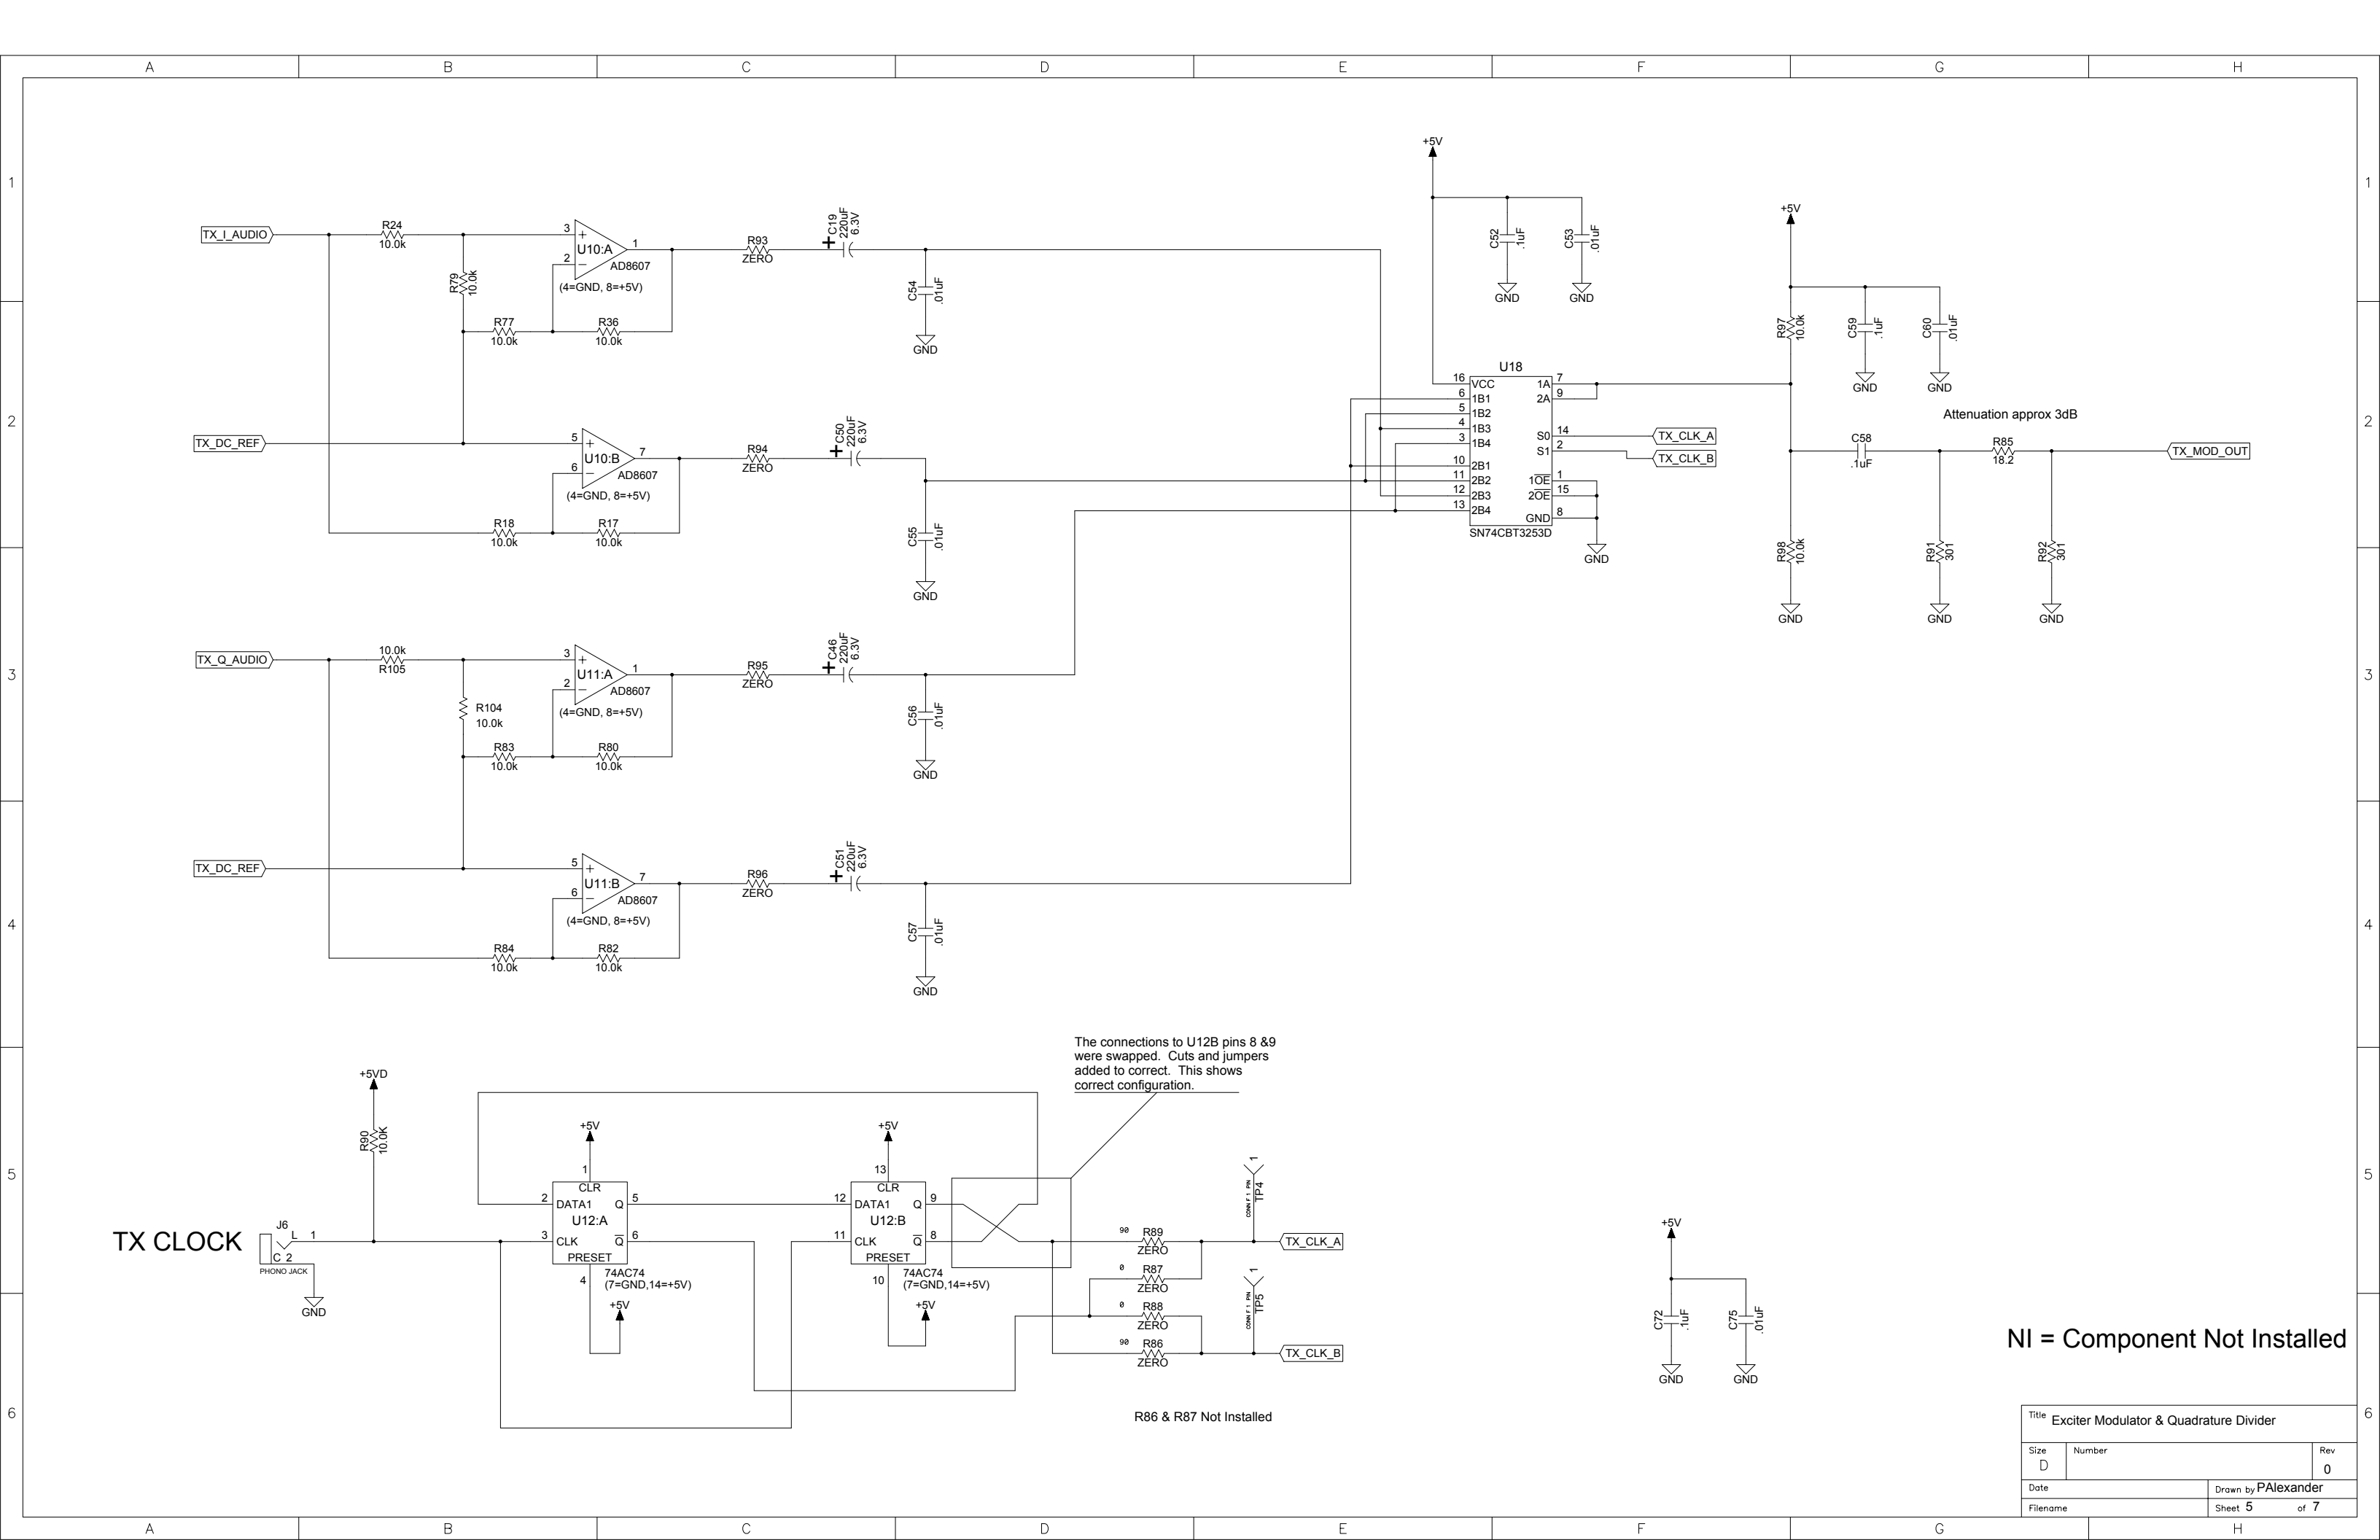
| Filename | Sheet 5 | of 7 |

The connections to U12B pins 8 & 9 were swapped. Cuts and jumpers added to correct. This shows correct configuration.

R86 & R87 Not Installed
